# Concrete Bridge Strengthening and Repair

Iain L Kennedy Reid

*Concrete Bridge Strengthening and Repair* seeks to make available to the reader the benefit of experience gained by Atkins in strengthening and repairing a wide range of concrete bridge elements resulting from a number of different types of defect.

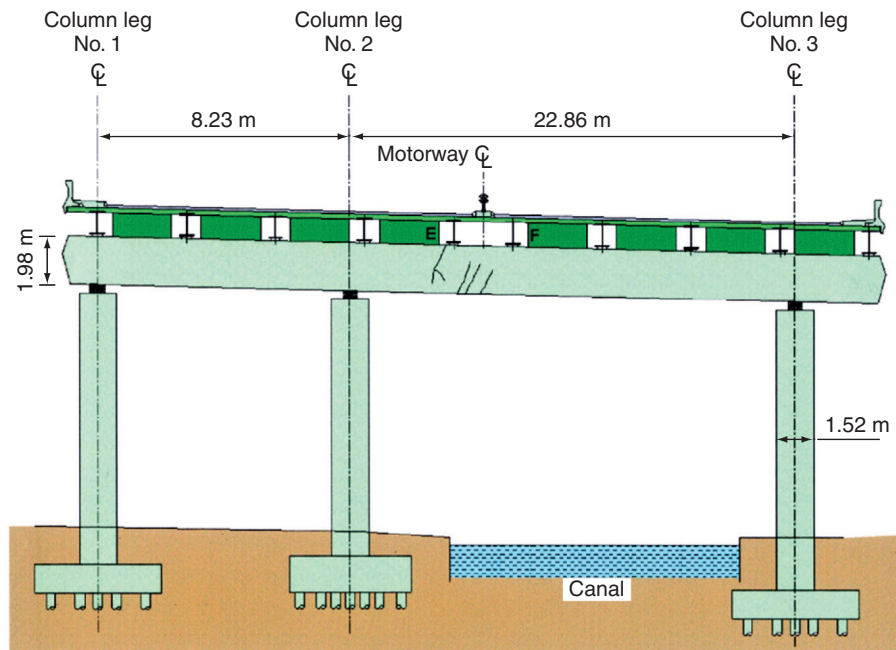
Figure 1.1 – Crossbeam elevation showing cracks

One of the largest crossbeams 30 m in length, 2 m deep and 1.7 m wide, traversing a canal and supported on three 1.5 m diameter columns, exhibited diagonal cracks some 15 years earlier. These were monitored and found not to be moving. However, some 10 years later additional diagonal cracks appeared and the degree of corrosion and delamination of the crossbeam was steadily worsening (see Figure 1.1).

The crossbeam was therefore assessed in its deteriorated condition. The actual loss of section of rebars was not considered to be significant and the crossbeam was found to have adequate shear strength provided by numerous links. The force in the longitudinal reinforcement was determined by the rigorous method proposed by Regan<sup>1</sup> allowing for the combined effects of shear and bending. The adequacy of the delaminated bond strength to provide sufficient anchorage at the point of curtailment at the location of the diagonal cracking was assessed on the basis of earlier model testing<sup>2</sup> and found to be just adequate. There appeared, therefore, to be no good reason for the diagonal cracking, particularly as settlement of the central column would reduce the applied shear at the crack location.

Nevertheless the structure was checked for signs of settlement. The bearing on the central column was found to be 15 mm lower than those on the outer two columns. To check whether this was due to settlement or to construction, the soffits of the deck beams were levelled and plotted and then corrected for long-term dead load deflection. The result was a settlement of the middle column by about 17 mm. The piled foundations were back analysed for anticipated settlement, and, due to its large size and applied loading, the middle foundation was found to have been susceptible to a settlement of, amazingly, 17 mm!

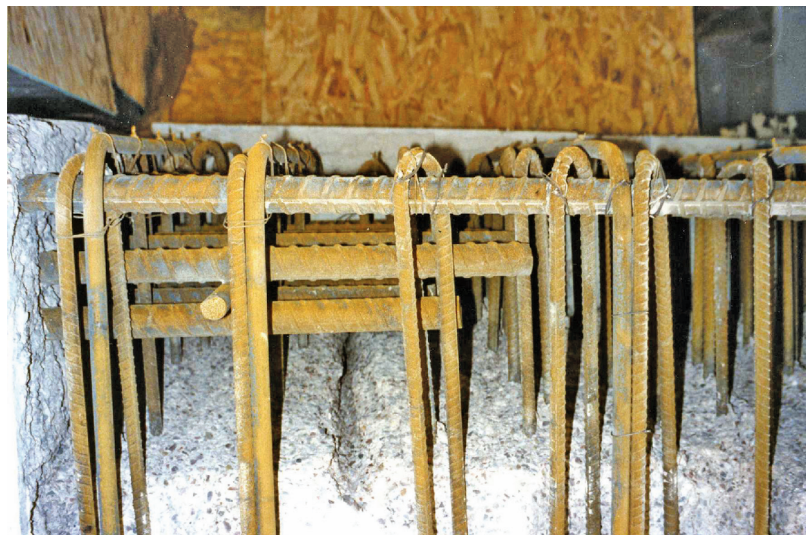
Figure 1.6 – Top of crossbeam broken out to enable insertion of anchor bars for strengthening nibs

Use was then made of the fact that much of the top and bottom of the beam would be systematically removed for repair of delamination. Reinforcement could be cast into longitudinal nibs provided at the beam corners and stitched into the top and bottom of the beam during repair. This would solve the problem of fixity to the beam and avoid conflict with items at the beam top and bottom. In the event this solution proved to be very successful and no major problems were encountered during construction (see Figure 1.5–1.7).

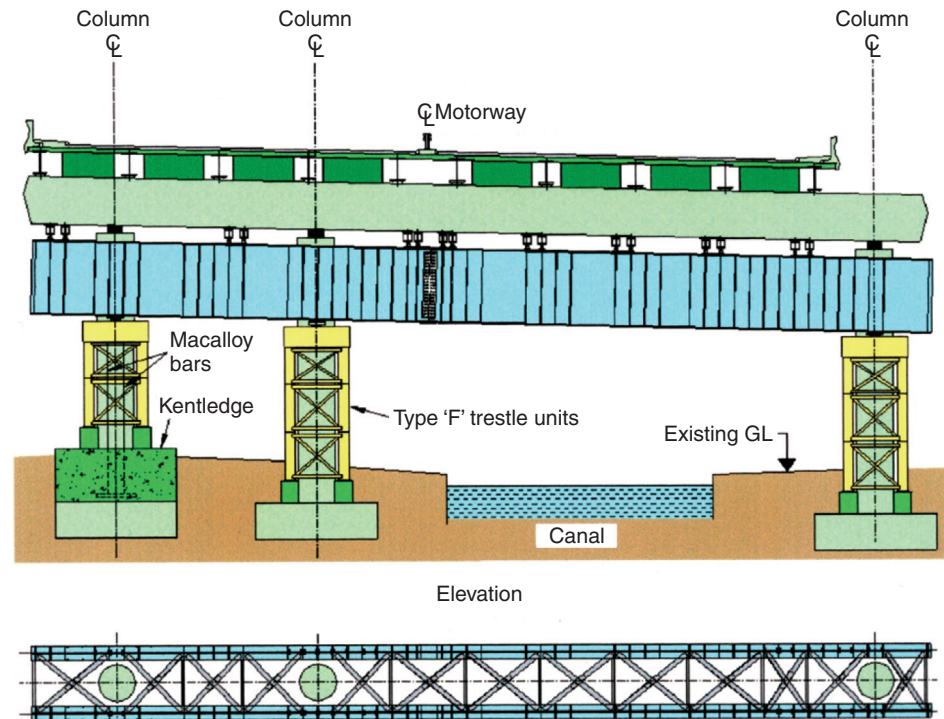
Figure 1.9 – Crossbeam supported by universal plate girder

As the columns were at imperial spacings, stiffeners were welded at a 2 foot modular spacing, and heavier bearing stiffeners were fixed to cover all bearing locations for each potential use of a particular girder. Plan bracing for all the girders could be fixed at 6 foot, 8 foot or 10 foot spacings and the permutations involved could cater for any column location. Standard holes were drilled in the flanges and stiffeners of each beam on the 2 foot module so that the bracing could be fixed at any 2 foot location. The holes in the 8 foot bracing members were straight, while those on the 6 foot and 10 foot members were skewed one way or the other so that any of the three plan bracing members could be bolted to the standard holes in the flanges (see Figure 1.8). The crossbeam described in this case study was propped by the Y1 girder (see Figure 1.9).

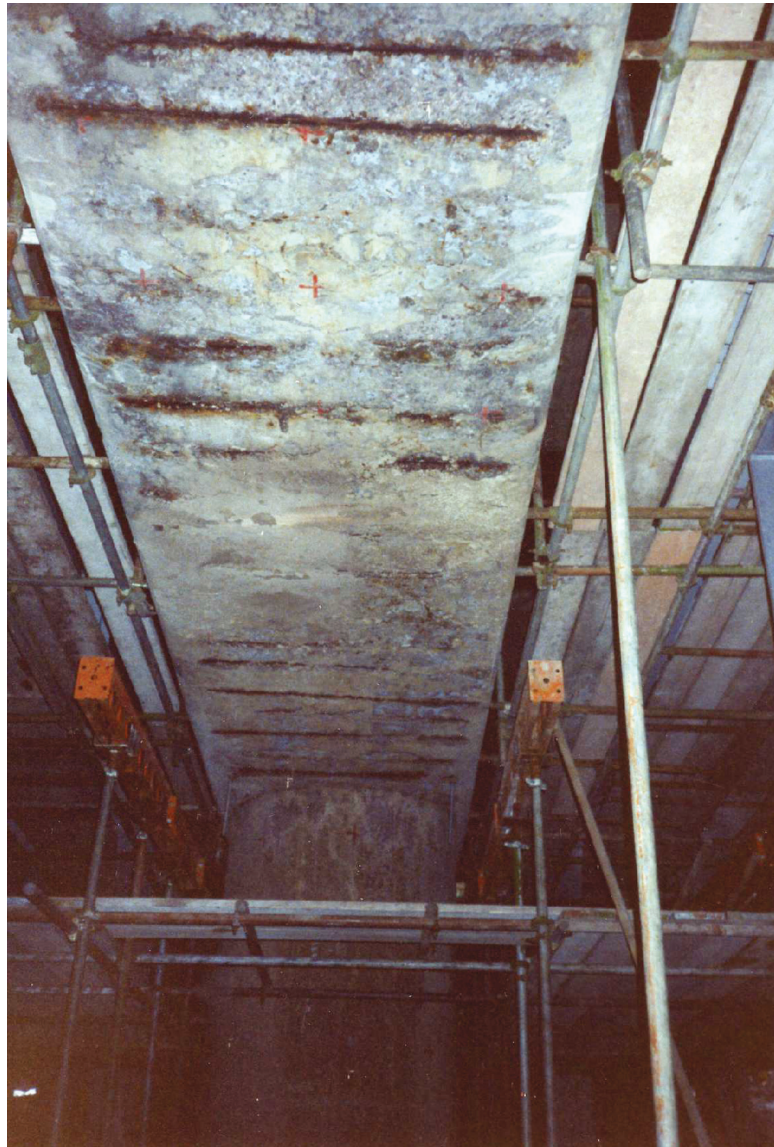
The crossbeam was considerably deteriorated due to corrosion of the top and bottom reinforcement caused by a combination of chloride contamination and lack of cover on the soffit (see Figure 2.2). There was approximately 50% delamination of the concrete surface and considerable loss of section of links and main bars. If the beam had been repaired by conventional methods of replacement of contaminated concrete, then 90% of the surface area would have had to be removed. For cathodic protection then all the delamination would have had to be repaired. The main reason for replacement, however, was the condition of the reinforcement and the practicability of repair. The basic requirement was therefore to remove the crossbeam completely and to construct a similar replacement. This work would have to be carried out with the minimum of traffic disruption.

*Figure 2.1 – Deteriorated crossbeam soffit*

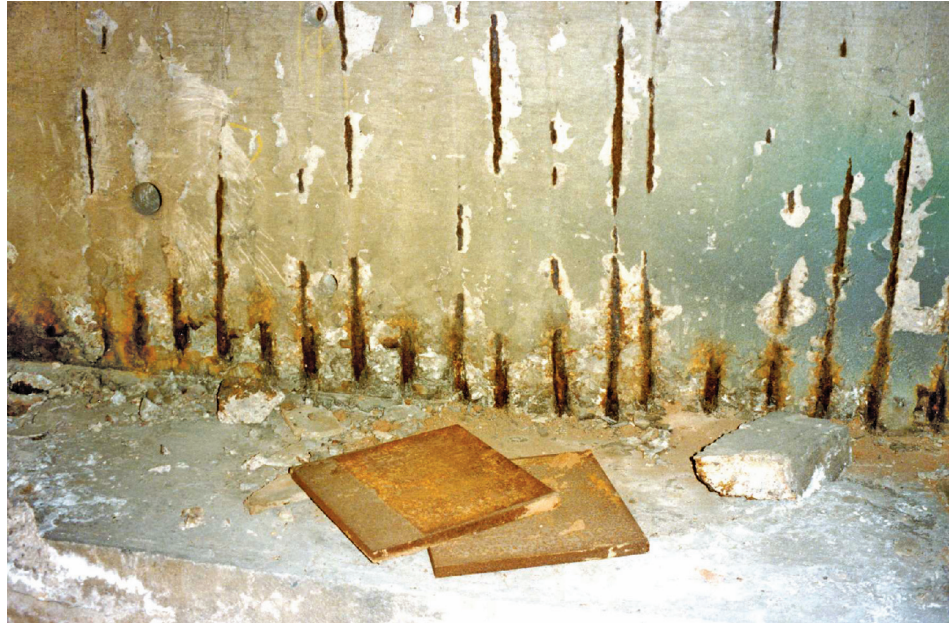
Many of the vertical bars and some of the horizontal bars in the panel walls were severely corroded with pitting corrosion towards the bottom of the panel walls with greatly varying loss of section, 40% loss being quite common. Consequently much of the area of the panel walls was delaminated. Sometimes the corrosion of the vertical bars encroached within the cover zone on top of the crossbeam (see Figure 3.2).

*Figure 3.2 – Concrete spalling due to corrosion of panel wall reinforcement*

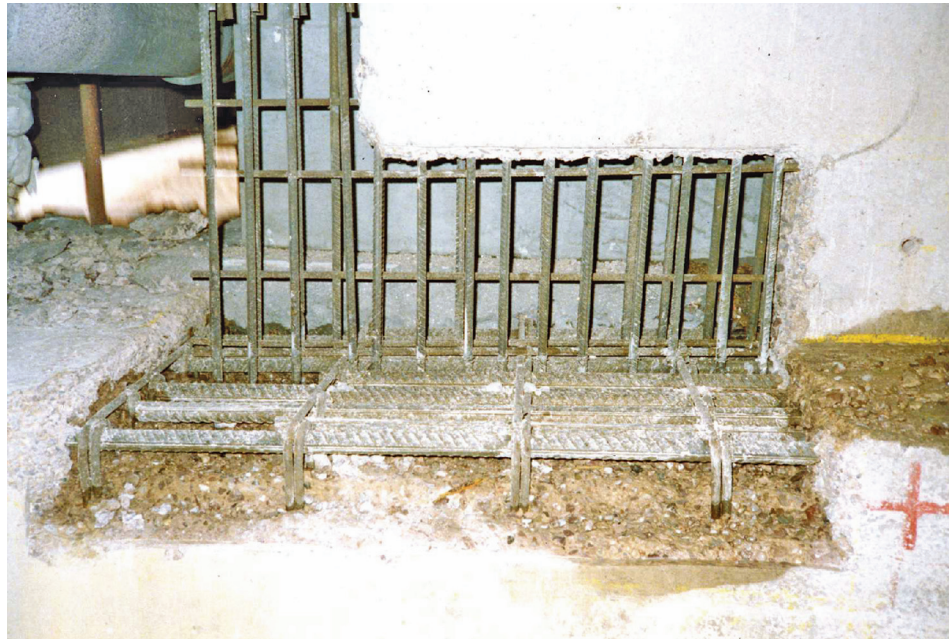
*Figure 3.3 – Concrete removed from panel wall by waterjetting*

Chlorides remained in the concrete in non-delaminated areas but ongoing corrosion in these areas would be arrested by the application of cathodic protection over all the panel walls. Assessment calculations were carried out to determine the average loss of section which could be tolerated on the vertical bars and sufficient bars were repaired to satisfy that requirement. Repairs were achieved by grinding off the pitted areas to a flat surface and refilling with weld metal, strictly following prior established weld procedures based on chemical analysis of the bars. Tensile tests had been previously carried out in the laboratory which proved the adequacy of such a repair technique.

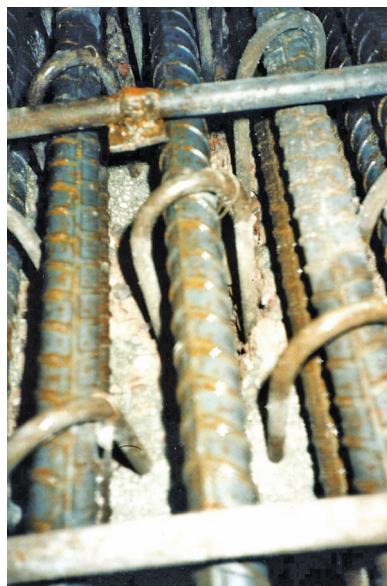
*Figure 4.1 – New length of torsion bar butt welded into position*

The links were also severely corroded, particularly at the bends (see Figure 4.2), and replacement lengths were welded in. Corroded ends of the hairpin links were strengthened by fillet welding additional horseshoe bends to the existing U-bend, since access was not available to cut these out and butt weld behind the closely spaced main reinforcement.

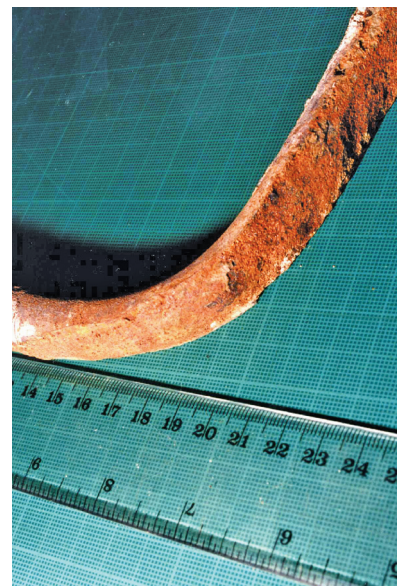
*Figure 4.2 – Corrosion of link bar at bend*

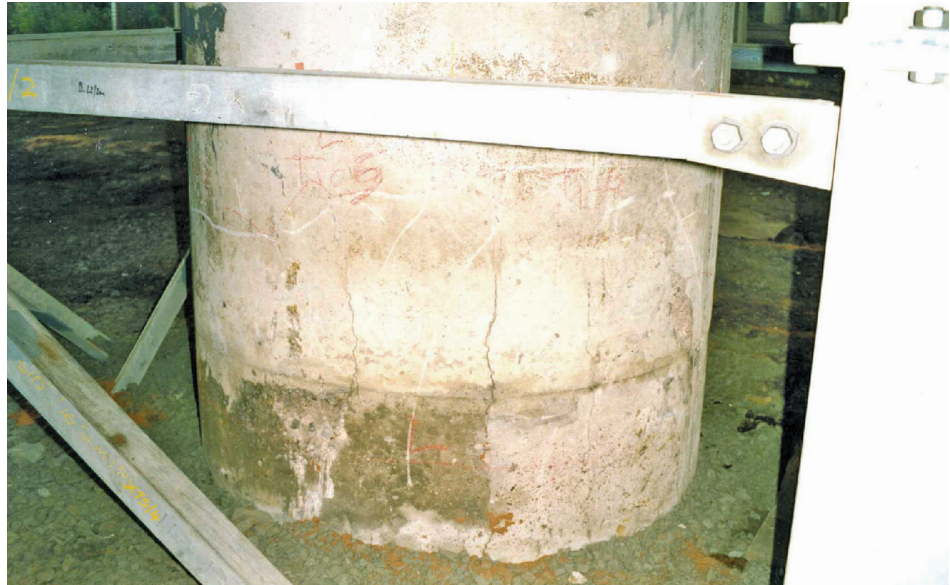
Circular concrete columns, monolithic with crossbeams and experiencing salt water run-off through leaking deck joints, were found to absorb chlorides at the top of the columns. Presumably run-off from the crossbeam and columns soaked into the ground adjacent to the columns, for the bottoms of the columns were also found to be contaminated with chlorides, possibly by capillary rise from the surrounding ground. Most column delamination occurred at the tops and bottoms of the columns (see Figure 8.1).

Figure 8.1 – Cracks indicating column delamination

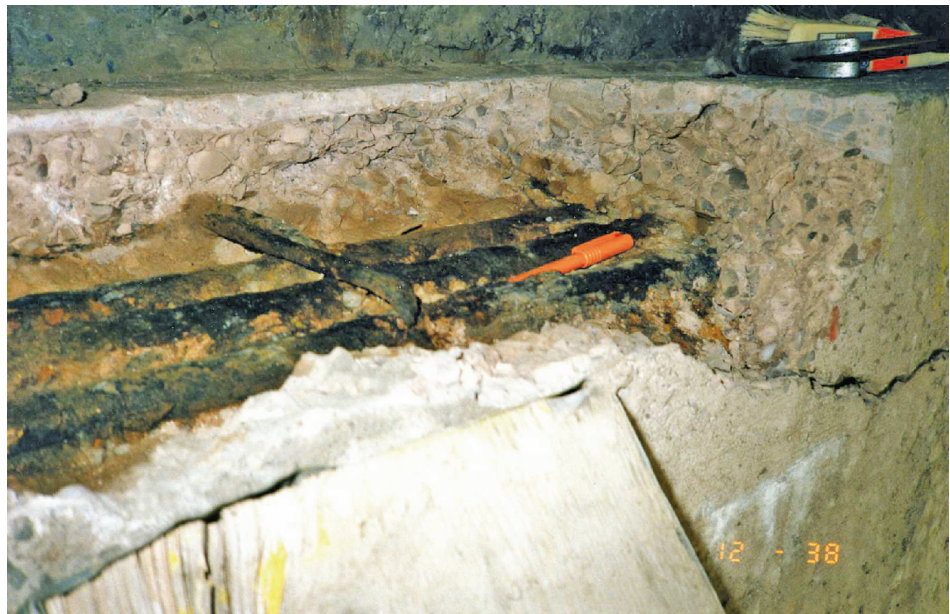
*Figure 10.1 – Torsion bar corroded right through*

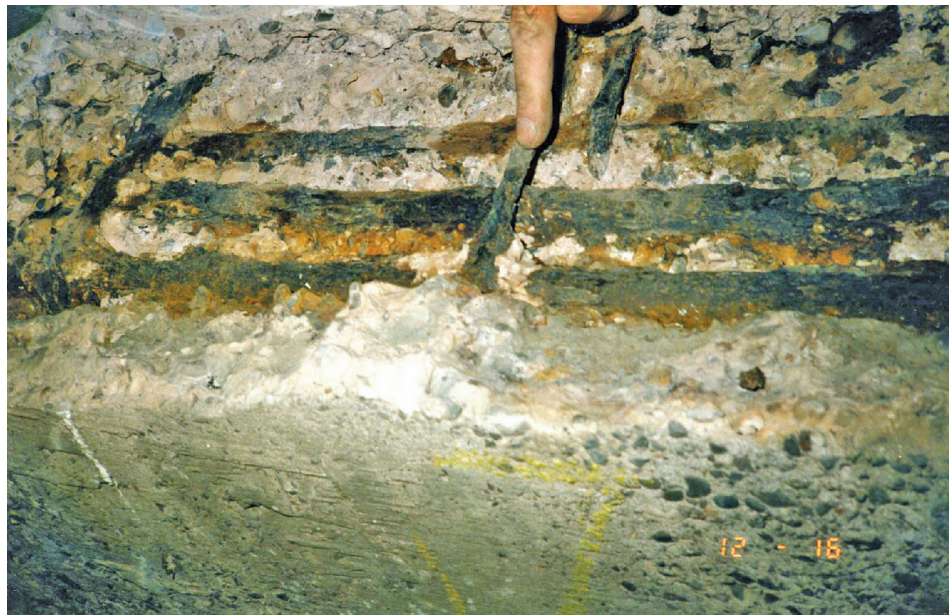
Figure 10.2 – Severe main bar corrosion

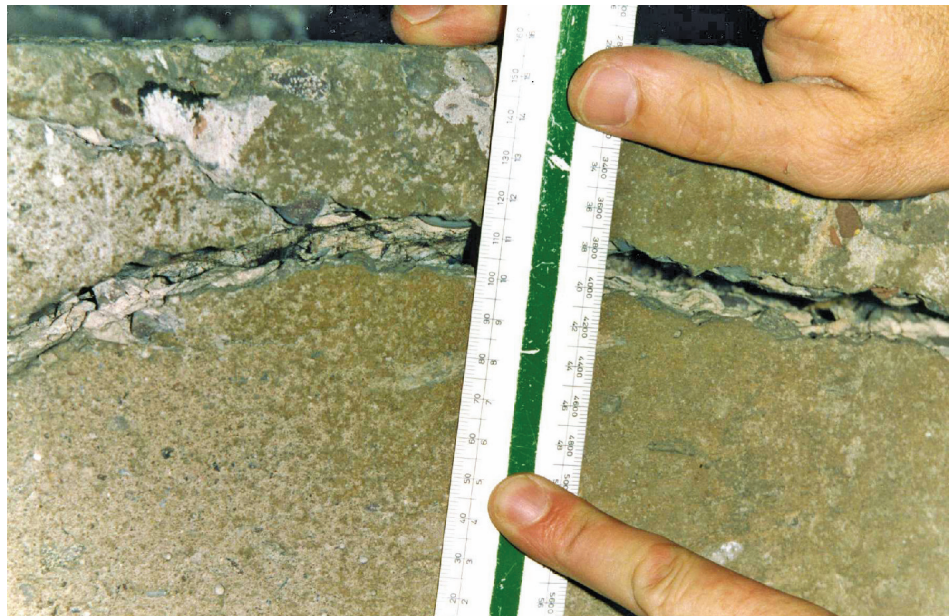
Figure 10.3 – Wide delamination crack in crossbeam top

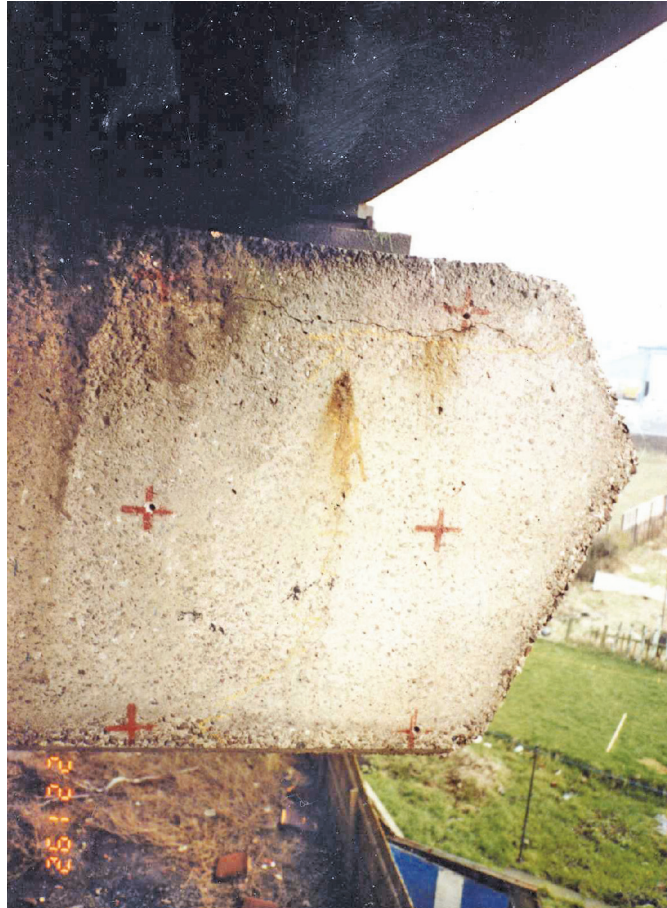
Figure 10.4 – Poor quality concrete

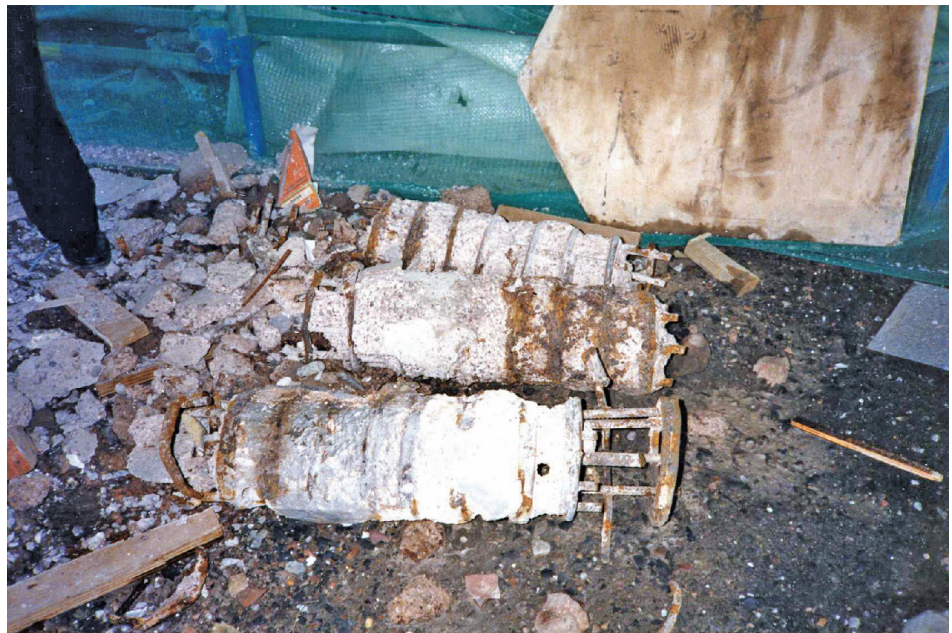
*Figure 15.7 – Discarded deteriorated stub columns*

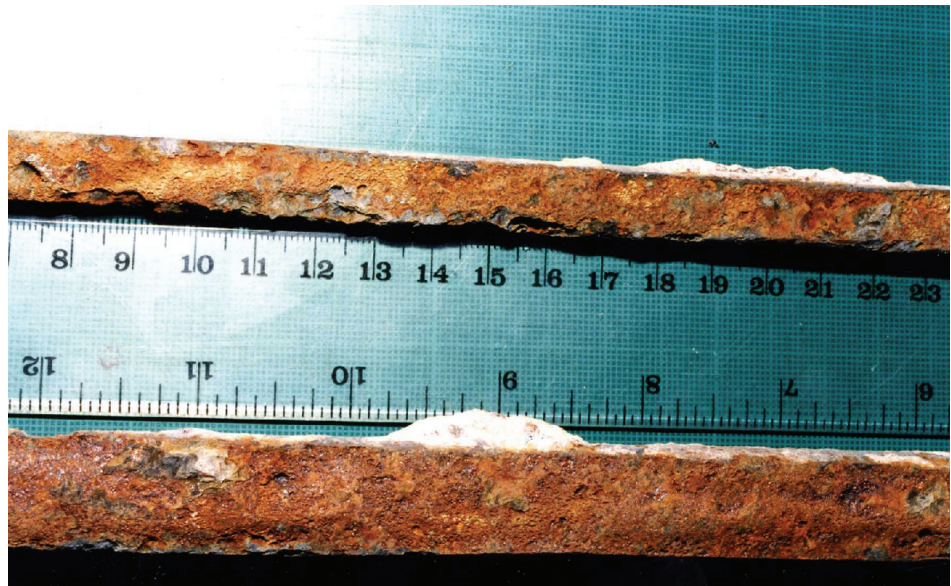
Figure 16.1 – Deck rebar pitting corrosion

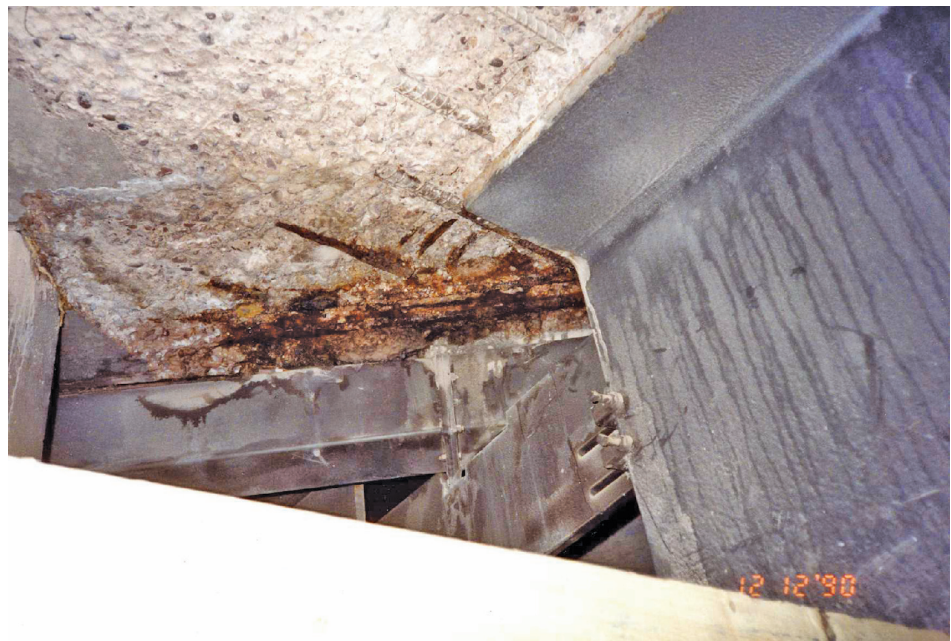
*Figure 19.1 – Deck soffit corrosion*

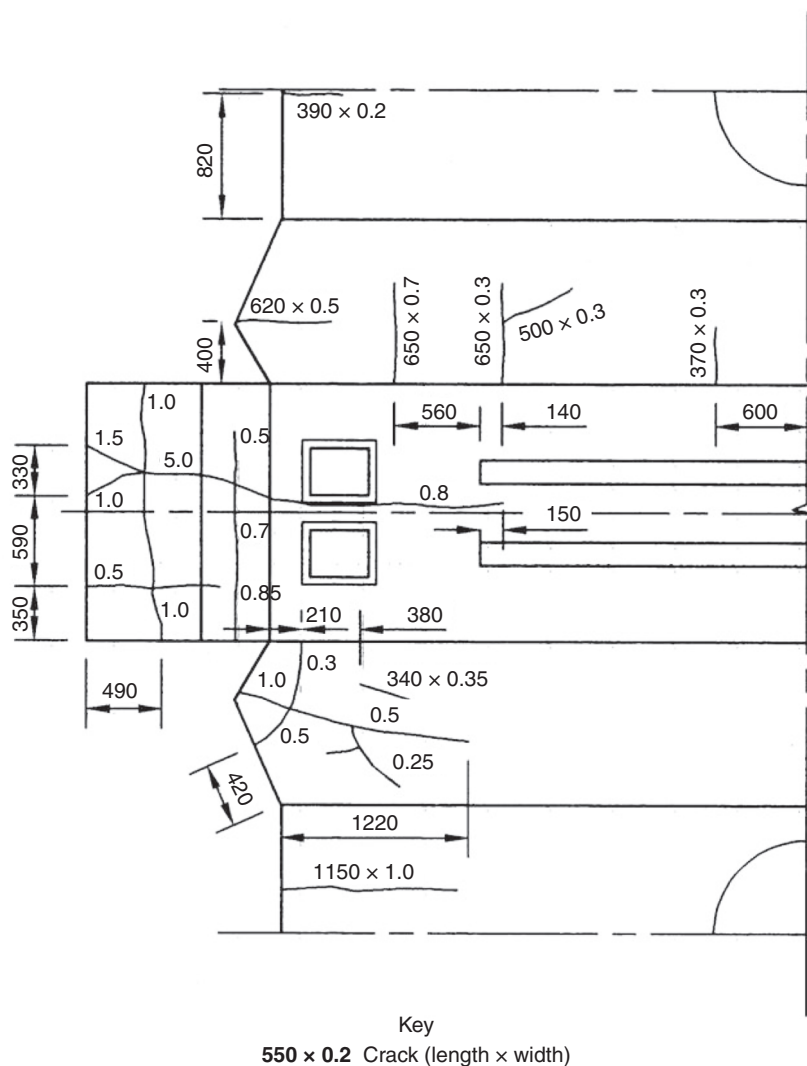
Figure 20.1 – Typical cracking on beam end
