FAILURES IN CONCRETE STRUCTURES

Case Studies in Reinforced
and Prestressed Concrete

Robin Whittle

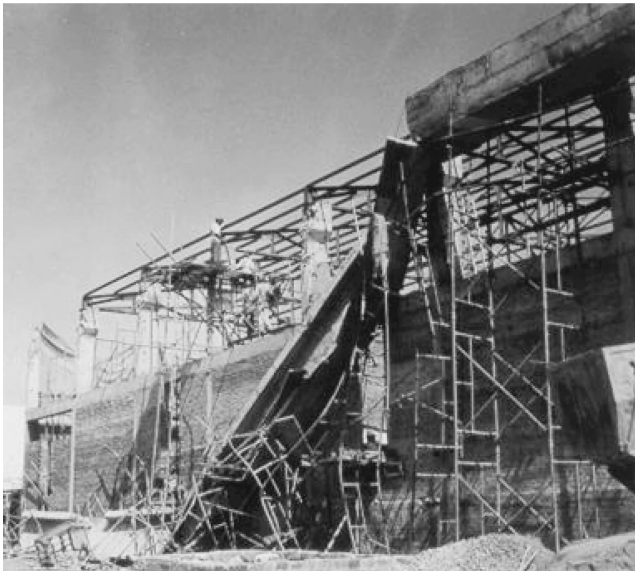
Figure 1.1 Collapse of concrete gutter.

The contractor had been using the gutter to pile bricks and sand. This load exceeded the design load and failure occurred.

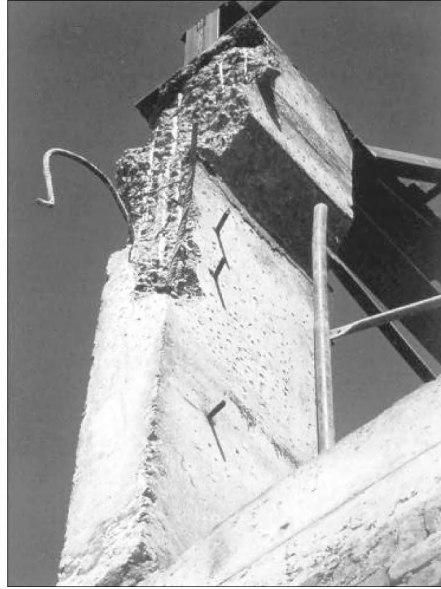
Figure 1.3 Column where edge beam has broken off.

Comment — Although the edge beam had been designed and detailed to resist the full load from the gutter (moment, shear, and torsion), this had not been carried through to the joint. The joint relied on the tension strength of the concrete which was not sufficient. This was a serious design error, but it is unlikely that the failure would have occurred if the gutter had been subject to just the load from rain. If the detailing and construction had been carried out thoroughly and correctly it is unlikely that the collapse would have occurred.

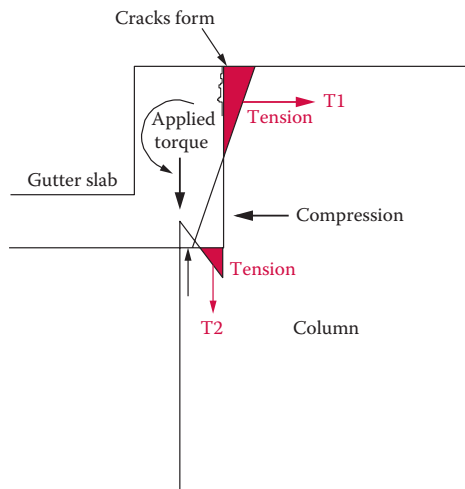
Analysis — Figure 1.4 shows a failure model based on the tension strength of the concrete. Even if the links that had been detailed to pass through the joint had been constructed this way, they would have been inadequate to support the loading.

Figure 1.4 Failure model relying on tension strength of concrete.

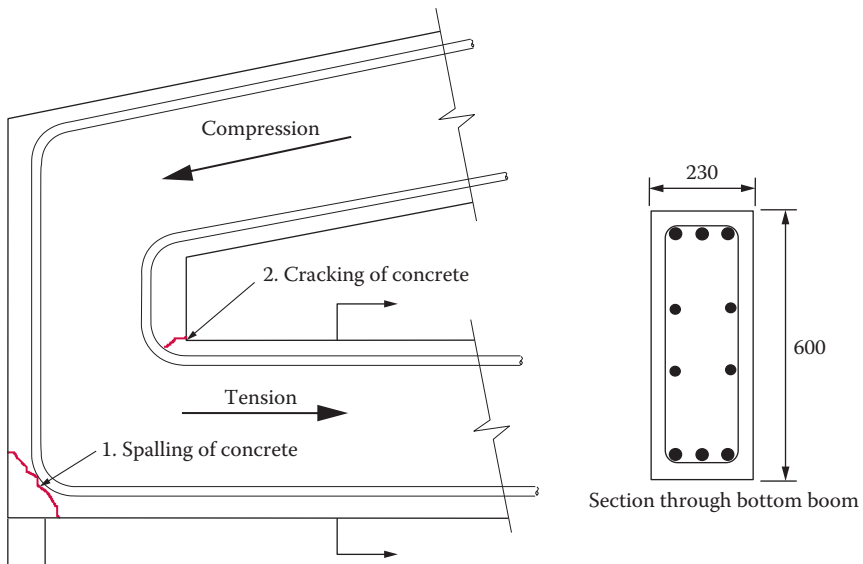
Failure of concrete at support (1 in Figure 1.8) — The support width was only 150 mm and the drawing did not show any reinforcement in the connection to the truss. If reinforcement was intended in the joint, then it would be difficult to fit this between the reinforcement of the truss. If not, the effect of the cover and the radius of bend of the T32 bars at the corner of the truss would lead to spalling of the concrete and the support would fail.

Failure of concrete at inner corner (2 in Figure 1.8) — Since the bottom boom was a tension member, the top reinforcement in it would be in tension. The way that it was detailed meant that a crack in the concrete would develop on the inside of the bend where it joined the vertical post at the end of the truss.

Figure 1.8 Concrete failure points.

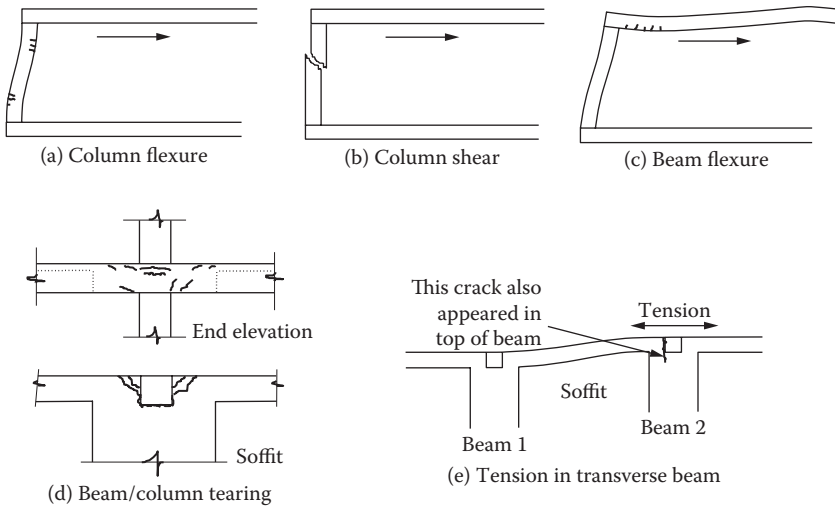
Figure 1.14 Different types of cracking.

widespread in both the columns and beams and exceeded 0.7 mm in places. Figure 1.14 shows the different types of cracking that occurred.

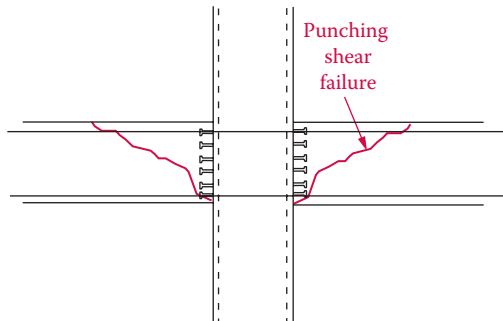
Figure 1.33 Punching failure of slab.

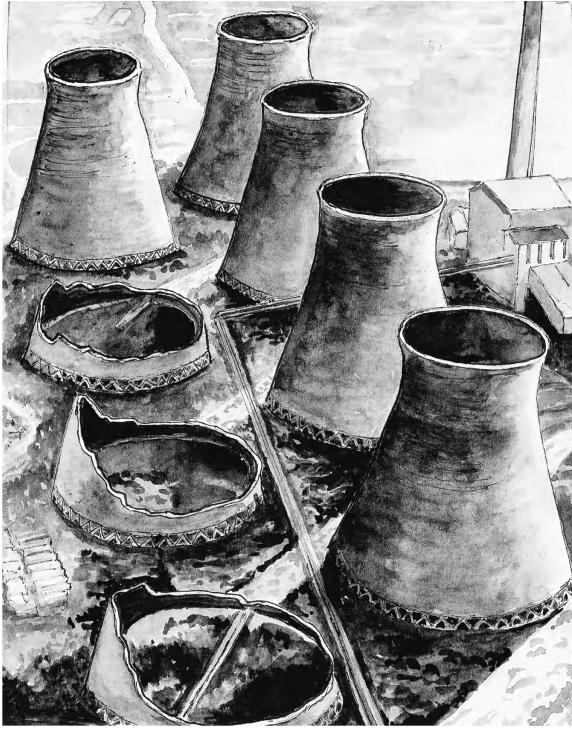
- British Standard wind speeds had not been used in the design; as a result, design wind pressures at the tops of the towers were 19% lower than they should have been.
- Basic wind speed was interpreted and used as the average over a 1-minute period, whereas, in reality the structures were susceptible to much shorter gusts.
- The wind loading was based on experiments using a single isolated tower. The grouping of the towers created turbulence on the leeward towers—the ones that did actually collapse.
- Safety margins did not cover uncertainties in the wind loadings.

Figure 3.1 View of collapsed cooling towers. (Courtesy of Gillian Whittle.)

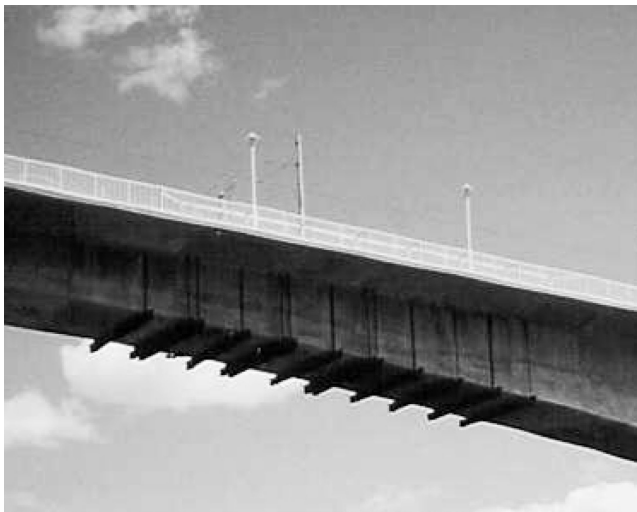
The design of a prestressed bridge section followed a code of practice that some considered to overestimate the shear capacities of prestressed beams. Soon after construction, cracks appeared. There was a long debate about the cause of cracking and, until remedial work was carried out, temporary additional external shear reinforcement was put in place (see Figure 3.5).

Figure 3.5 Temporary repair work on bridge.

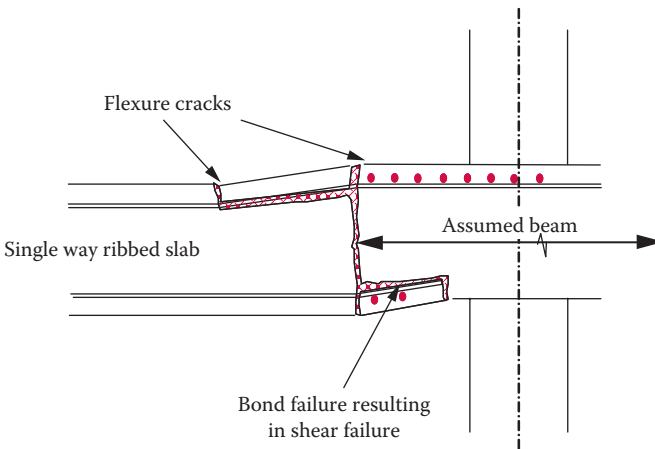
Figure 4.3 Section through ribbed slab at failure.

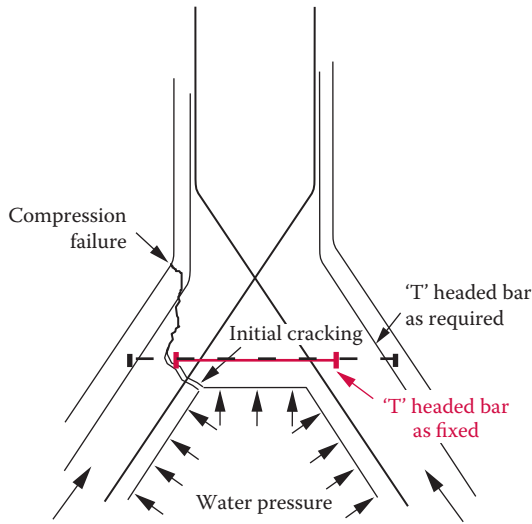
Figure 6.4 Section through tri-cell where failure occurred.

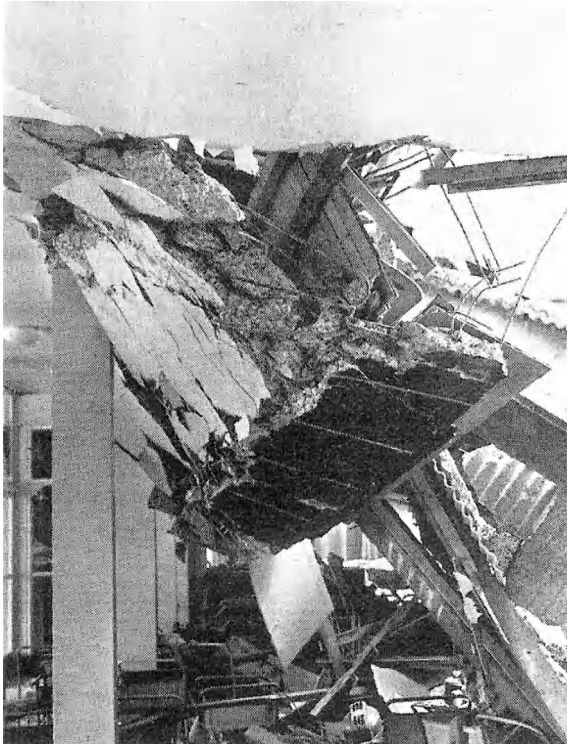
Comment — This was an example of inadequate design and poor detailing of the end bearing nibs built into the supporting beam for the precast beams. The reduction in strength caused by HAC left no margin for temperature effects. The combination was likely to have triggered the collapse.

Figure 6.6 Part of roof that collapsed on chairs below. (From Scott, G.A., *Building Disasters and Failures*, Construction Press Ltd., Lancaster, 1976. With permission.)

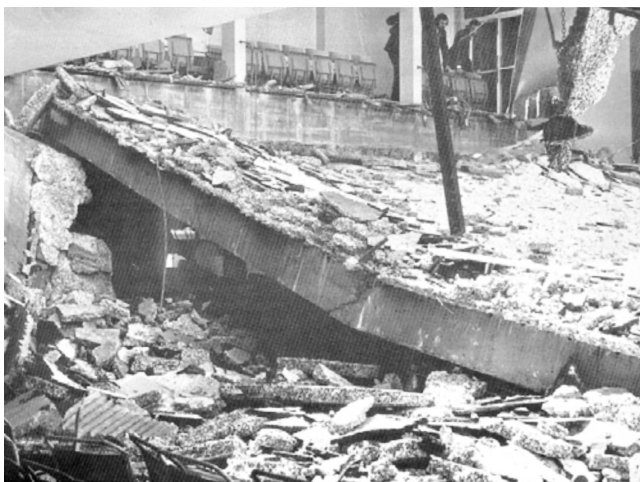
Figure 6.7 Collapsed roof lying on floor below. (From Scott, G.A., *Building Disasters and Failures*, Construction Press Ltd., Lancaster, 1976. With permission.)

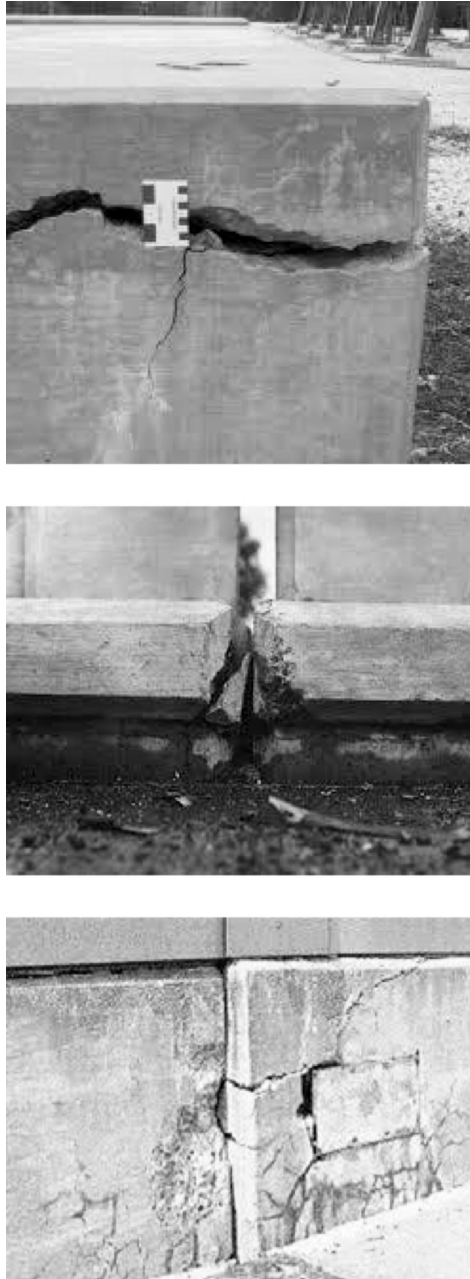
In mainly unidirectional reinforced members, the cracks become linear and parallel to the reinforcement. The degree of cracking depends on the amount of confining reinforcement, i.e., links, etc. One major concern was that ASR caused cracking that led bits of concrete to fall off structural elements and hit people below. This led to demolition of the structures in some cases. Examples of ASR effects are given in Figure 7.6.

Figure 7.6 Examples of alkali-silica reaction. (Top: From the US Department of Transportation Highway Administration; middle: From Dr. Ideker, <http://web.engr.oregonstate.edu/~idekerj/>; bottom: From the US Department of Transportation Highway Administration.)

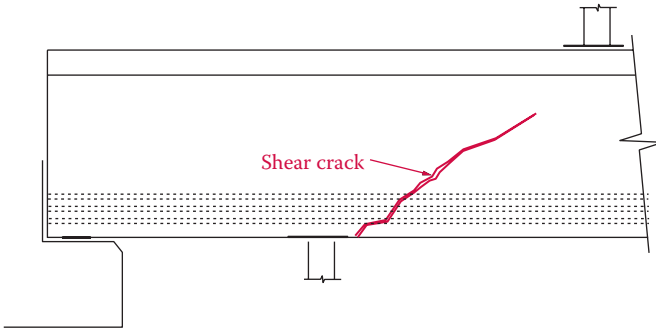
Figure 8.3 Cracked T unit.

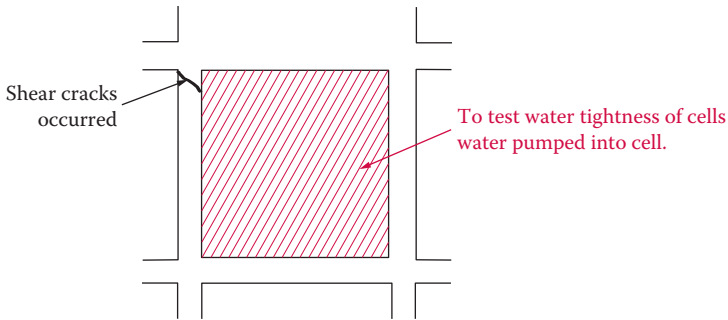
Figure 8.13 Shear crack in wall.

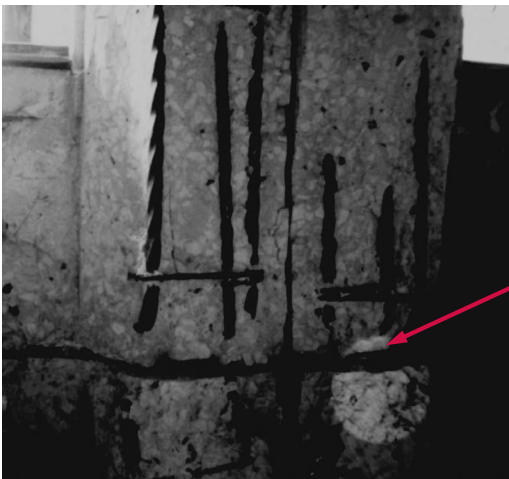
Figure 8.17 Spalling of mullions. (Courtesy of Poul Beckmann.)

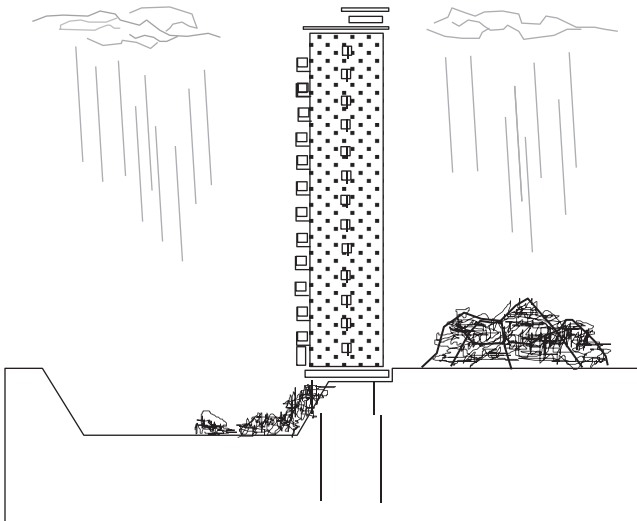
Figure 10.5 Diagrammatic view of pile shear failure.

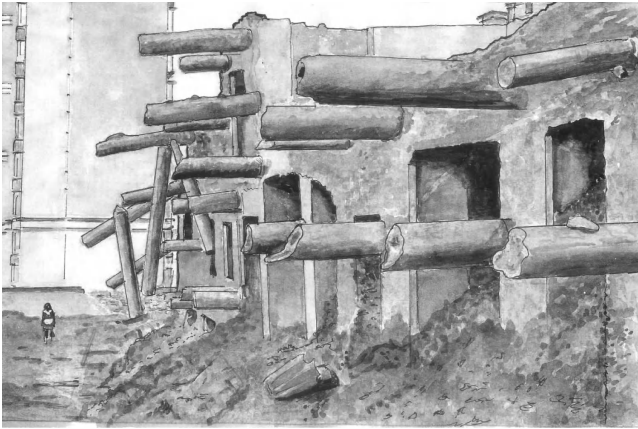
Figure 10.8 View of piles that failed in shear. (Courtesy of Gillian Whittle; redrawn from Reuters, <http://www.telegraph.co.uk/news/worldnews/asia/china/5685963/Nine-held-over-Shanghai-building-collapse.html>.)

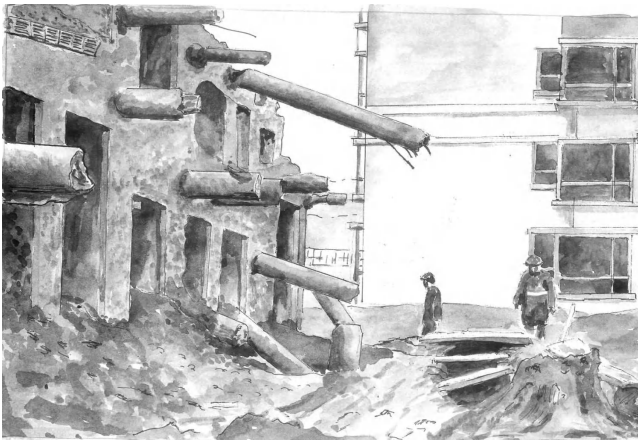
Figure 10.9 Unreinforced piles with short reinforced length at tops. (Courtesy of Gillian Whittle; redrawn from Reuters, <http://www.telegraph.co.uk/news/worldnews/asia/china/5685963/Nine-held-over-Shanghai-building-collapse.html>.)

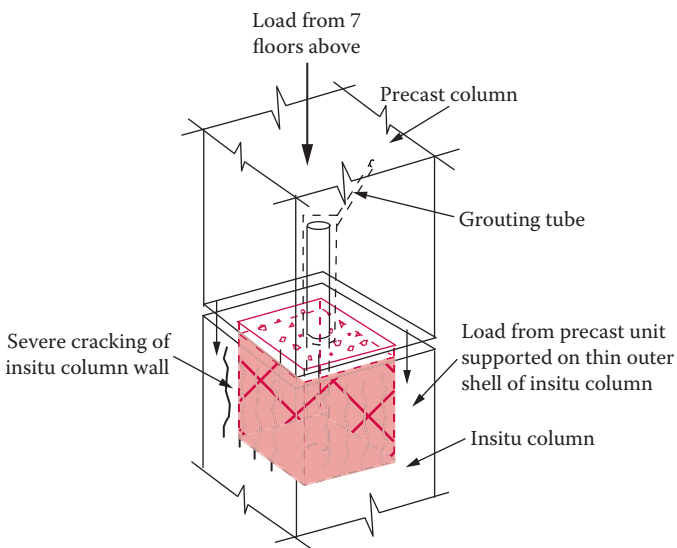
Figure 11.5 Cracking of outer rim of in situ column.
