# Concrete Bridge Strengthening and Repair

Iain L Kennedy Reid

*Concrete Bridge Strengthening and Repair* seeks to make available to the reader the benefit of experience gained by Atkins in strengthening and repairing a wide range of concrete bridge elements resulting from a number of different types of defect.

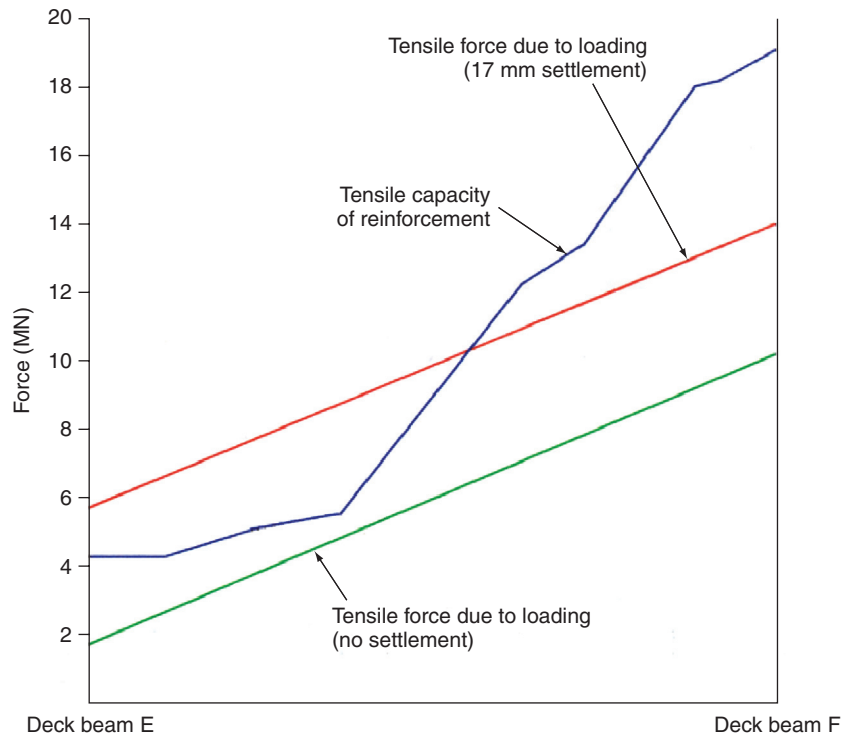
Figure 1.2 – Capacity of main bottom reinforcement

This settlement was then applied to the assessment of the deteriorated crossbeam and found, due to the addition of sagging moment, to increase significantly the force in the longitudinal reinforcement (see Figure 1.2). The capacity ratio dropped to 0.65 under 45 units of HB loading. A load restriction of 100 tons was immediately imposed on the structure and the hard shoulder closed.

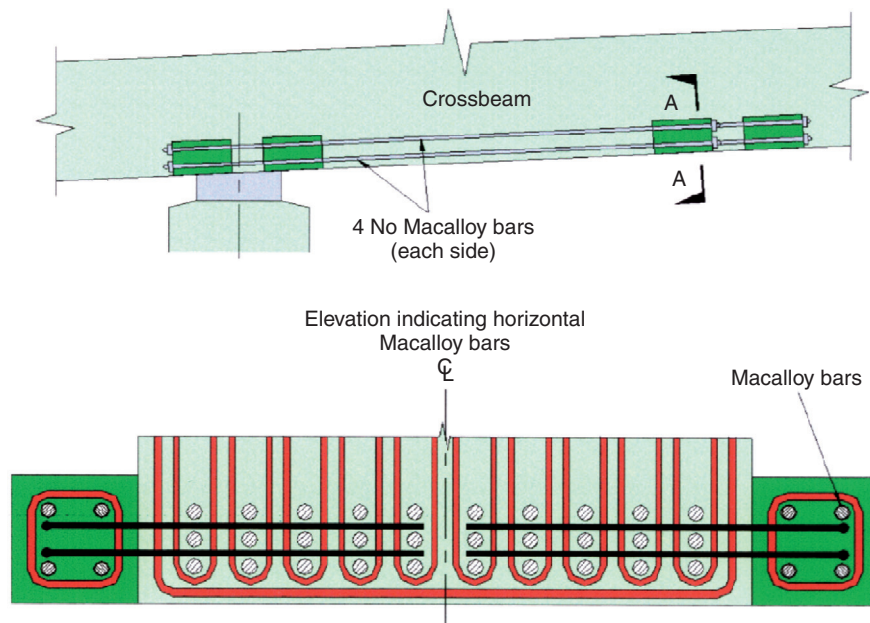
Figure 1.4 – Macalloy bar proposal

Means then had to be devised as to how the crossbeam could be strengthened. External prestressing was considered, but the beams have little vertical and no longitudinal reinforcement in the side face, so anchorage to the sides of the beam would have been a problem. Fixity to the top or bottom of the beam would also have been difficult as the longitudinal bars are so closely spaced that bolting between them, and missing the links, would have been problematic (see Figure 1.4).

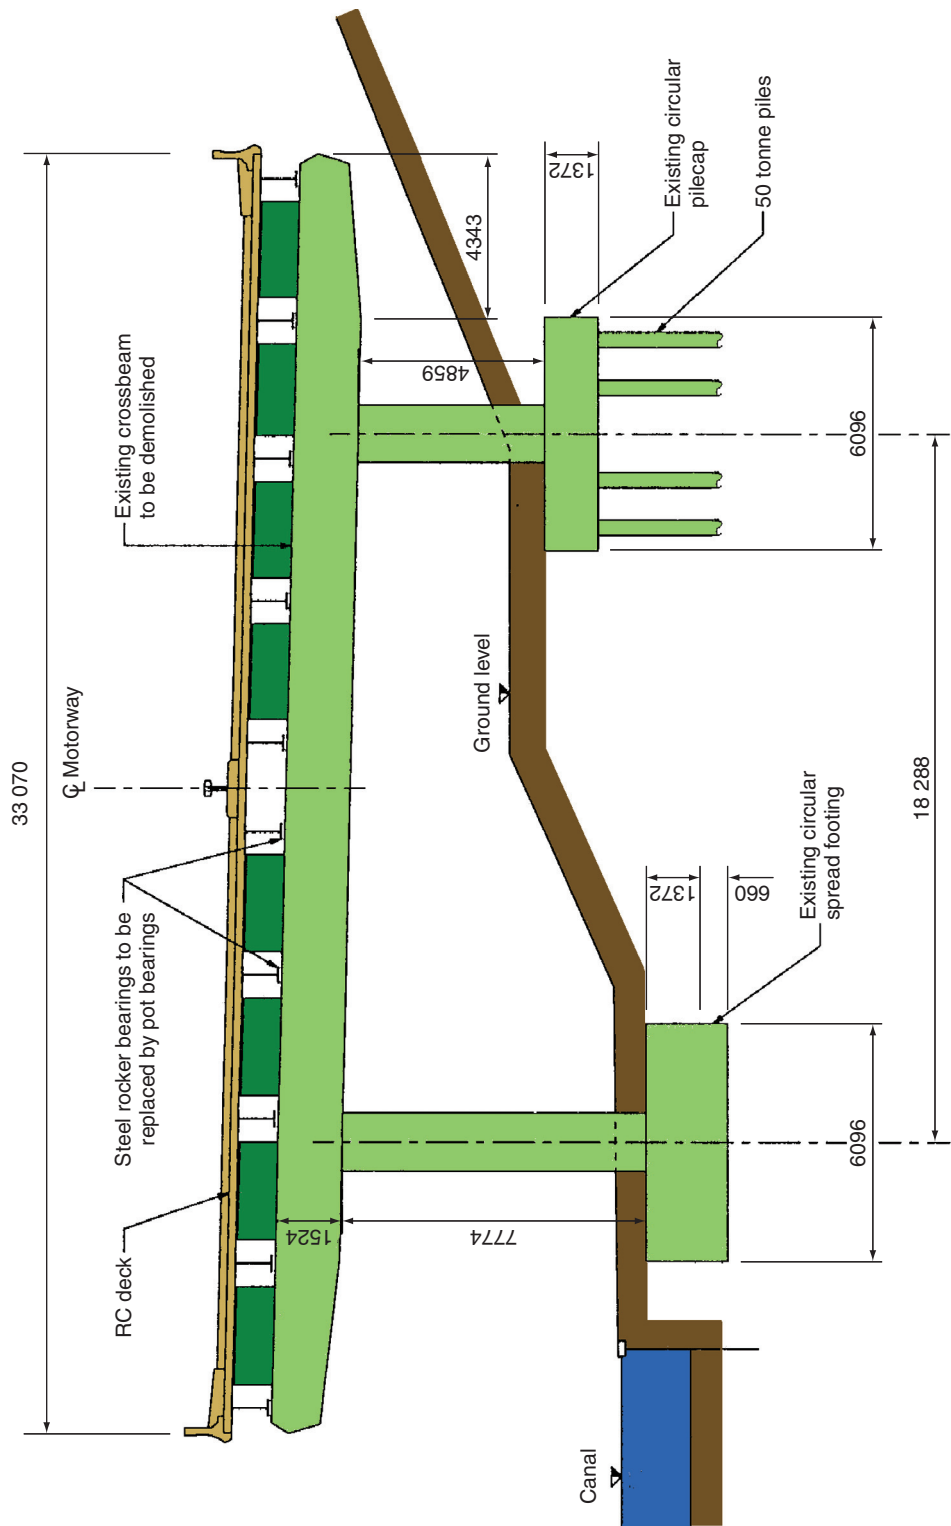
Figure 2.2 – General arrangement of crossbeam

In the case of this particular crossbeam it was located adjacent to a canal on one side and an embankment on the other side which interfered with access and affected the structural solutions (see Figure 2.2).

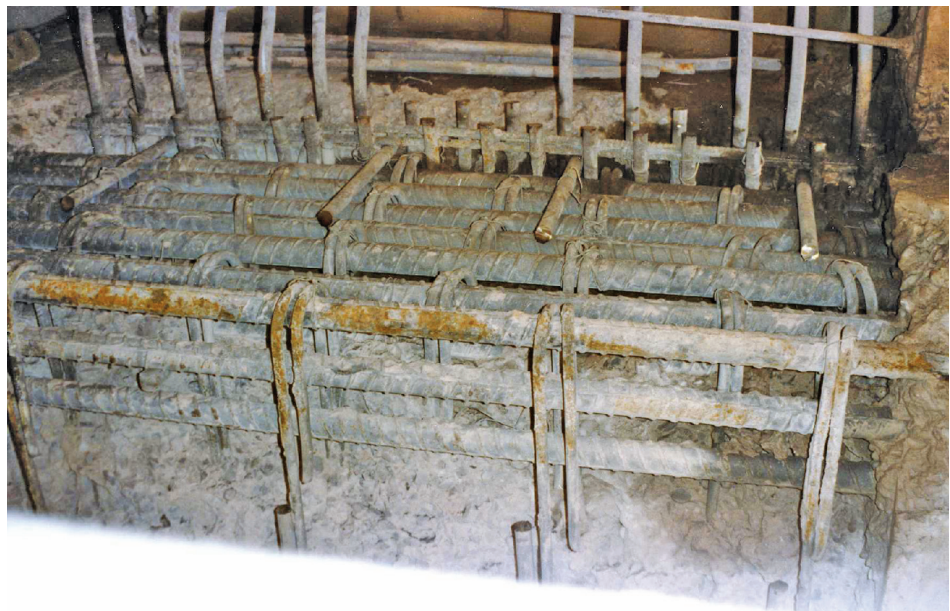
Figure 3.1 – Panel wall vertical reinforcement cranked into position originally

Problems encountered on the panel walls included diagonal cracking resulting from transverse shearing forces derived from shrinkage of the deck slab concrete. Further problems arose whereby during construction the large longitudinal bars in the crossbeam had been misplaced, preventing correct positioning of the vertical bars in the panel walls. The latter bars had then been cranked immediately above the crossbeam to bring them into position and provide the correct cover to the panel walls (see Figure 3.1). The result was that at the bottom of the panel wall the required lever arm was not provided by the vertical bars so that the required bending resistance of the panel wall was far from being achieved.

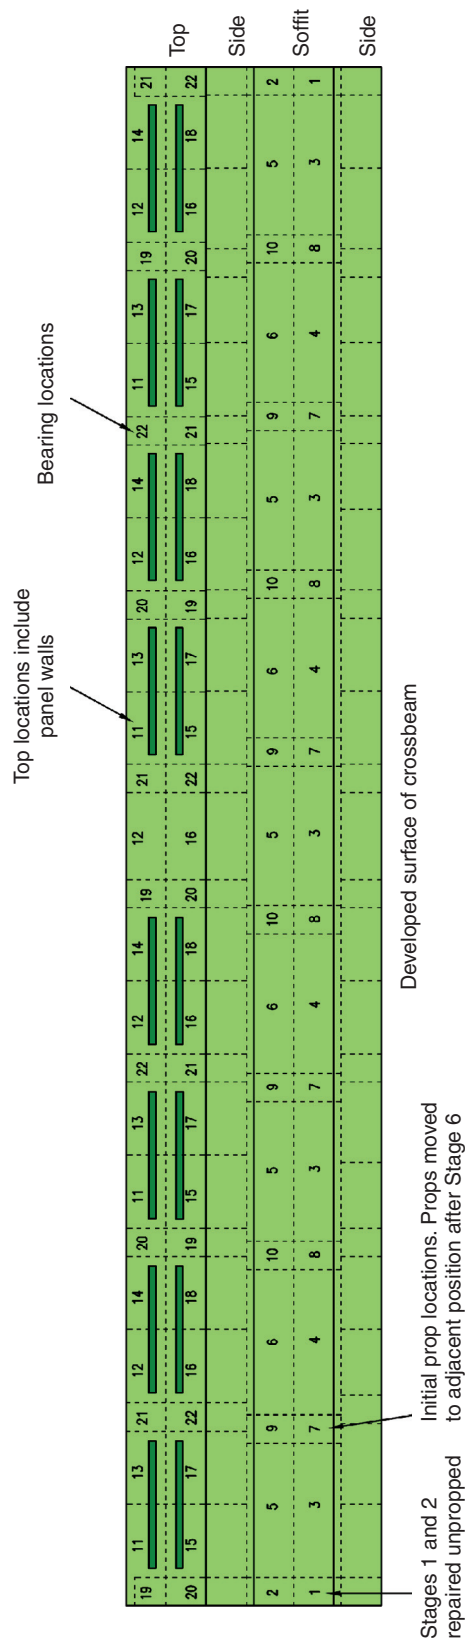
Figure 4.10 – Typical propped crossbeam repair sequence

After the concrete had gained strength, sample holes were drilled in the soffit and a boroscope used to check for the absence of air gaps. The jacks were later moved to alternative locations to enable the remainder of the soffit to be repaired. The soffit was preferably repaired first so that the construction joint on the side of the beam could generally be formed by concreting from above. Discrete delaminated areas towards the centre of the crossbeam soffit were broken out from the side face, both to enable horizontal water-jetting, and to avoid the formation of air gaps. In water-jetting normal to the face of the concrete, it would have been very difficult to avoid creating deep holes in the broken out surface of the concrete.

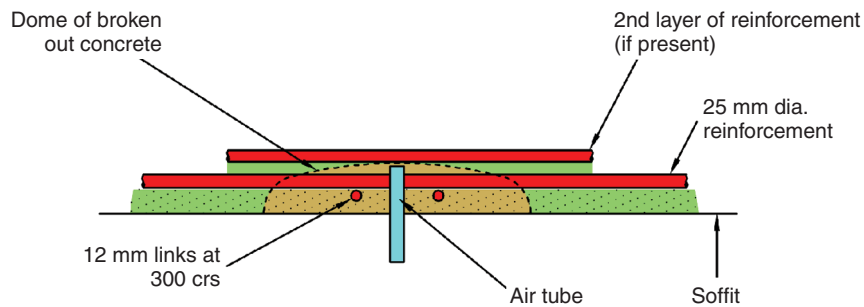
*Figure 4.11 – Domed soffit repair*

Some crossbeams over highways could not readily be propped and a method was developed for repair without propping of small areas of delaminated soffit which did not extend to the face of the beam. The concrete was broken out by hand to behind the outer layer of reinforcement to form a domed soffit to the broken out concrete. A vertical plastic tube was inserted through the formwork just short of the top of the dome. When the concrete was pumped into the void, it overflowed through the tube, ensuring any residual air gap was limited to a tiny area at the top of the dome (see Figure 4.11). The ends of the crossbeam were repaired unpropped by breaking out to the edge.

Note: Dome formed between two layers of reinforcement only if propping for normal soffit repairs to edge of crossbeam impracticable.

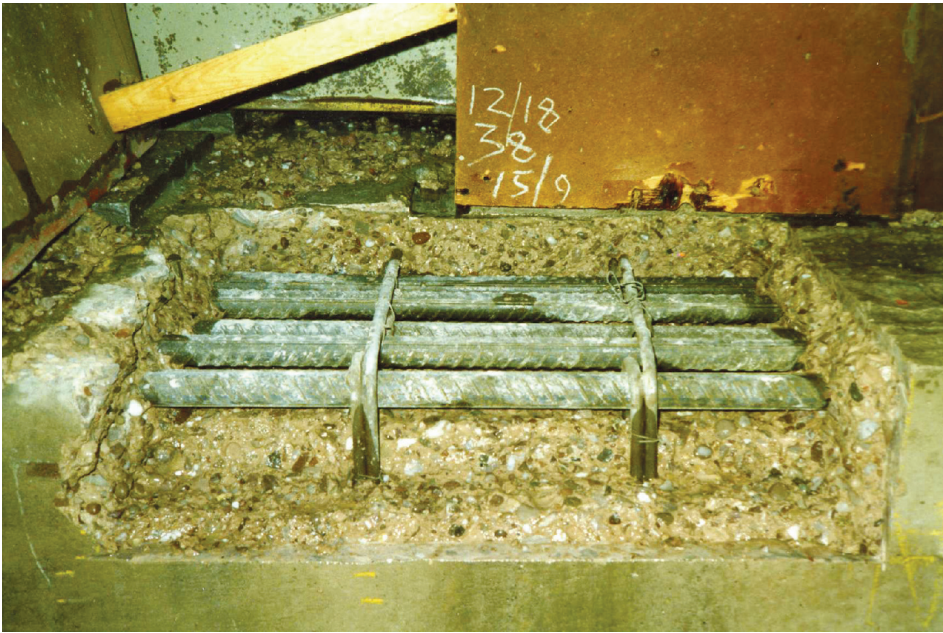
Figure 4.12 – Break out to top of crossbeam

The top and sides of the crossbeam were repaired together with water-jetting parallel to the top of the beam. The sides were easily jetted due to the absence of longitudinal reinforcement. The top of the beam only needed to be broken out behind the top layer of reinforcement, since reconcreting from above was straightforward (see Figures 4.12 and 4.13). Reduced flowing concrete was used in the top of the beam to enable the concrete to be cast to the fall of the top of the beam. Repairing under bearings is described in a separate case study.

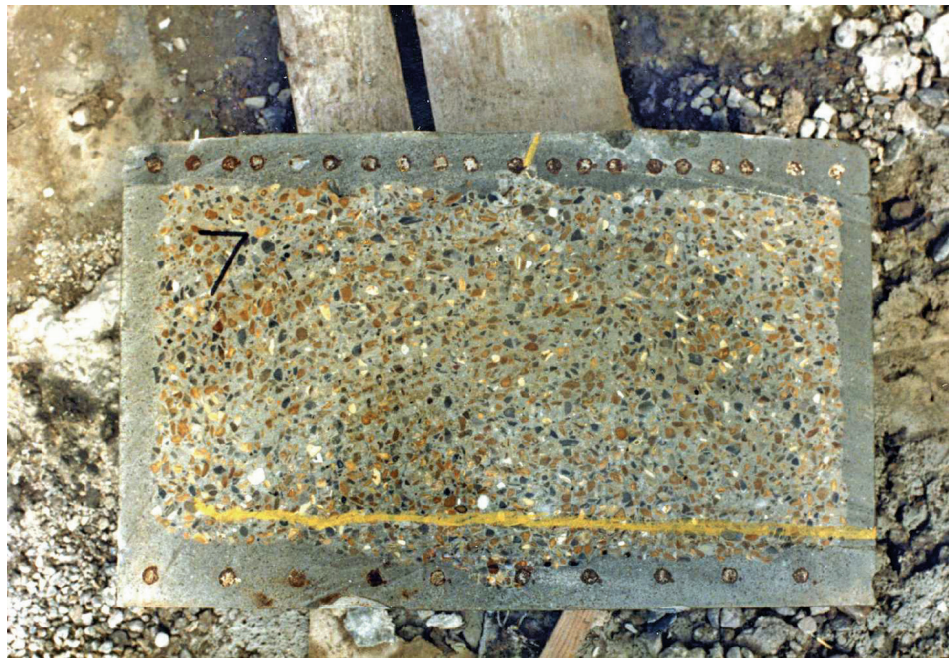
*Figure 5.1 – Model beam repair*

Some 24, one-third scale models were built representing the most common configurations of the cantilevers. Some were in pristine condition, some with the concrete cast or scabbled flush with the main bars and some were repaired flush with, or behind, the reinforcement (see Figure 5.1). Corrosion was represented by notching the main bars at 100 mm centres through 10, 20 or 30% of the cross-sectional area, and the corners of the stirrups through 30, 60 or 90% of the cross-section. The beams were loaded to failure and the results analysed (see Figure 5.2). Tensile tests of the notched bars indicated that strain hardening occurred at the notch, so that the loss of strength was by no means proportional to the loss of section. However, the loss of bond strength due to delamination was highly significant.

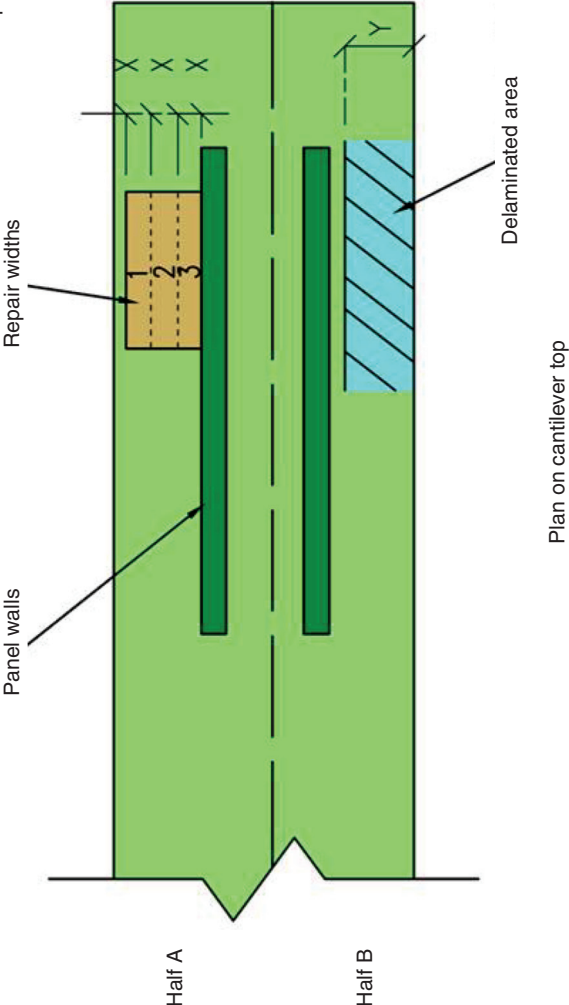
Figure 5.4 – Cantilever repair diagram

<i>Repair diagram</i>	Following analysis of the delaminated strength, diagrams were prepared, indicating the areas on the cantilever tops permitted to be broken out in sequence (see Figure 5.4). At the beginning of the sequence only small areas could be removed due to the extent of delamination, while towards the end of the sequence larger areas could be removed as a result of the increased strength of the areas by then repaired. The locations, as well as the size, of the repair areas were critical.
<i>Monitoring</i>	Some cantilevers, not the most vulnerable type, had not been repaired by the time hard shoulder running was required for deck repairs, and these were resurveyed, then monitored weekly for increased delamination and for potential shear cracks during the period of regular hard shoulder running.
<i>Cathodic protection</i>	As with the remainder of the crossbeams, cathodic protection was applied to arrest further rebar corrosion within the non-delaminated areas impregnated with chlorides. Concrete was broken out a little way beyond the actual delaminated area for repair in case progression of the delamination occurred before the cathodic protection could be applied.

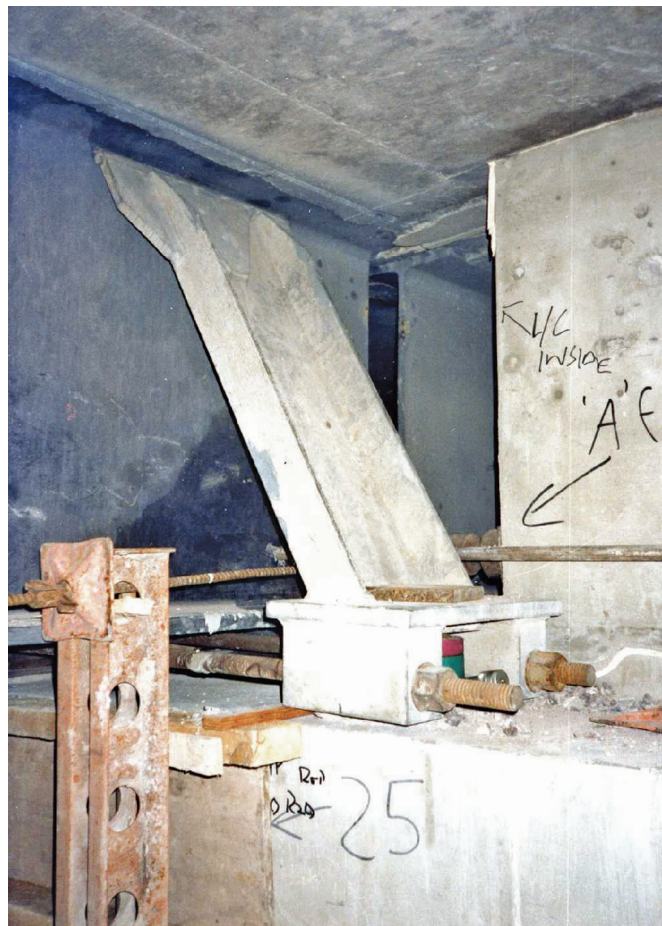
Figure 6.1 – A-frame for repair below bearing

The crossbeams were repaired under bearings where delamination against the plinth occurred on at least two sides of the bearing to an extent that delamination was likely to have extended beneath the steel bearing plate. The deck beam was supported under the top flange against the top of the web by a steel A-frame lifted on jacks either side of the bearing plinth (see Figures 6.1 and 6.2). The bottom of the deck beam web was strutted against the adjacent concrete panel walls for stability and the dead load in the deck beam transferred to the jacks. The bearing holding down nuts were released and the bearing clamped to the bottom flange of the deck beam. The plinth was water jetted out, as was the concrete in the top of the crossbeam, jetting from the crossbeam side between the jacks.

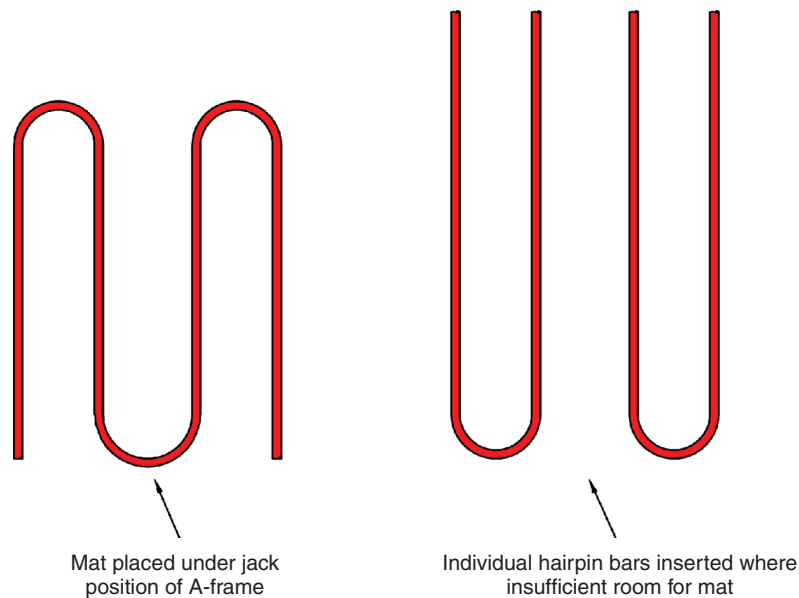
Figure 6.3 – Anti-splitting reinforcement mat

As this involved a significant area of breakout, repairs under bearings were only carried out with the crossbeam propped. The only transverse reinforcement in the crossbeam top continuous across the beam was the torsion bar and these were at 300 centres. This meant that between the broken out concrete under the bearing and the jack position, there might be no transverse reinforcement to prevent splitting of the concrete under the jack. As the repairs were carried out under live traffic, the precaution was taken to provide a mat of anti-splitting reinforcement under the jack positions during concrete repairs to the areas either side of the bearing, prior to the repairs under the bearing (see Figure 6.3). (The jacks were in a more vulnerable position close to the side of the crossbeam, so that the transverse Macalloy ties of the A-frame could pass beneath the deck beam in front of the bearing).

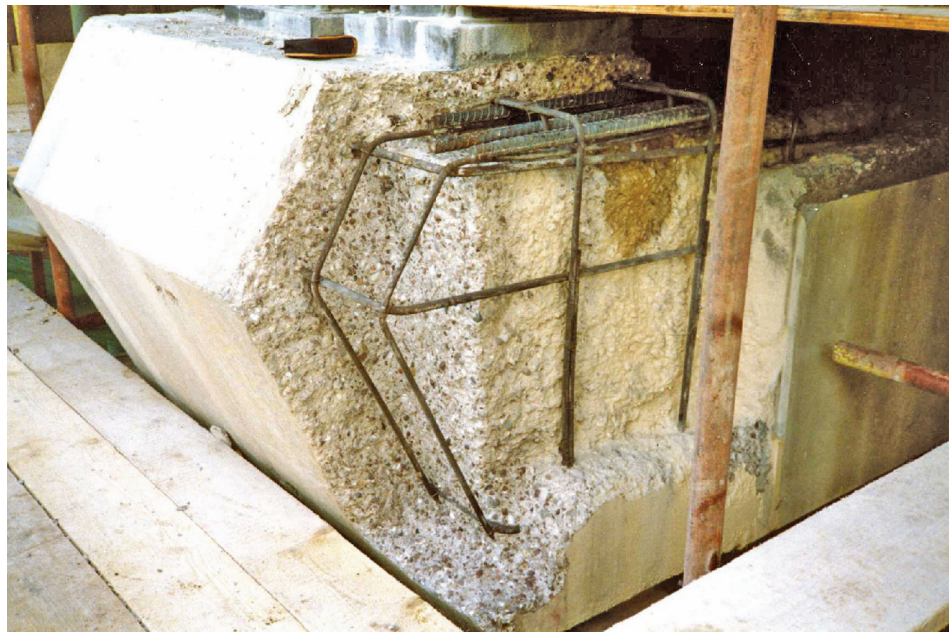
*Figure 6.4 – Breakout for addition of concrete nib to carry wide A-frame*

For the shorter spans, a narrow A-frame was required at the outer crossbeam to enable the jack to fit on the end of the crossbeam. For the longer spans and therefore larger bearings, a narrow A-frame could not be used, and a concrete nib extension was built on to the end of the crossbeam to accommodate the jack (see Figures 6.4 and 6.5).

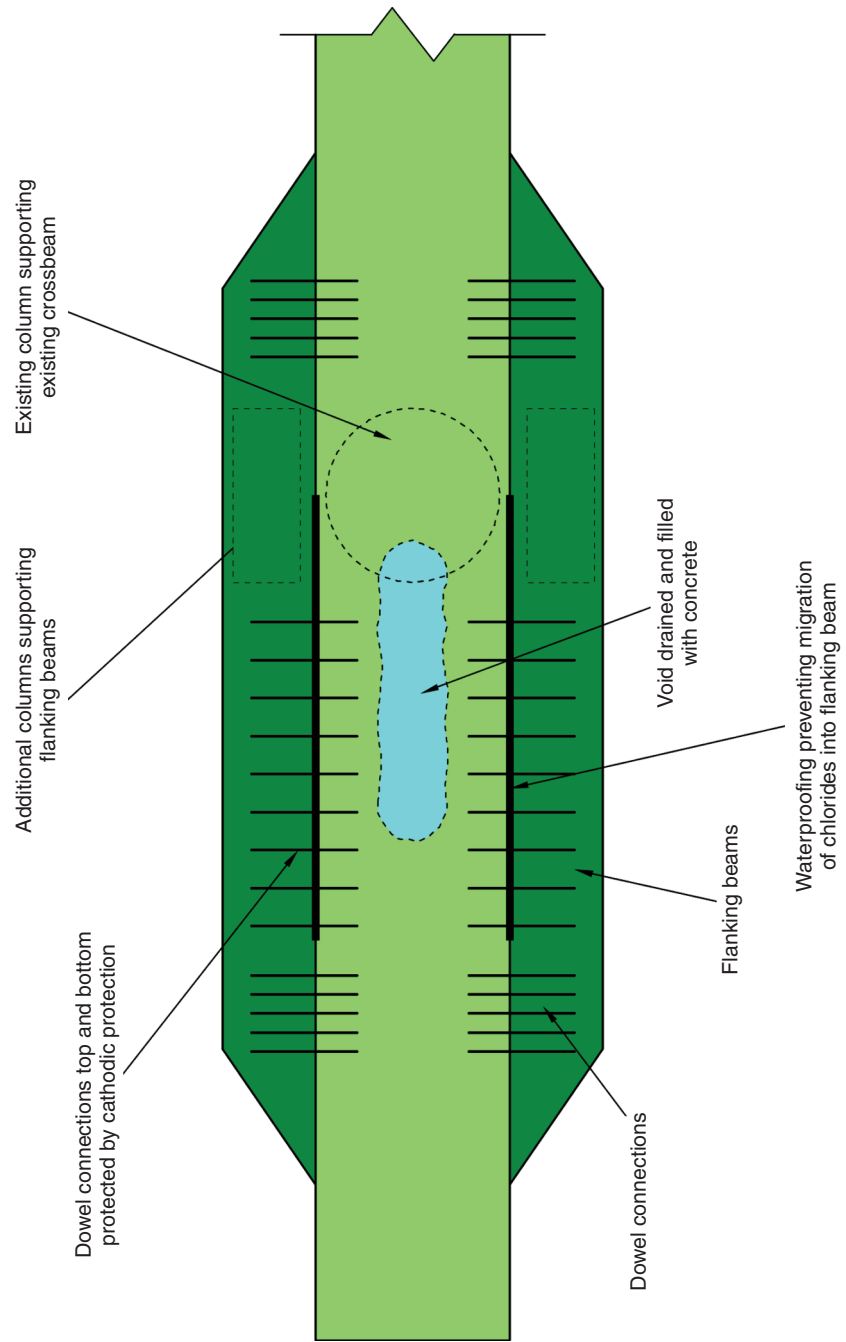
Figure 7.1 – Proposed flanking beams

When crossbeams were being repaired for road salt impregnation, corrosion and delamination, water-jetting the top of a propped crossbeam exposed a hole in the concrete below the top layer of reinforcement. This appeared to give way to a void. Drilling small holes in the top of the crossbeam revealed eventually a void 2 m in length, 600 mm at its widest and 450 mm at its deepest, full of salt-laden water. The crossbeam was 1.67 m in width and 1.5 m deep. A hole was drilled in from the side to disperse the water. The links through the void were severely corroded, some almost completely through.

After being cleaned out as far as possible, the void was therefore reconcreted and the repairs to the crossbeam were continued. It appeared that the void formed below an area of three layers of main reinforcement at close centres through which vertical bars passed, also at close centres, to form the panel walls above. Apparent lack of vibration during concreting had prevented the concrete flowing through the dense mat of top reinforcement in the region of the panel walls.

The proposal was to construct flanking beams alongside the crossbeam, enabling the force actions to bypass the voided zone, since repair of the reinforcement deep in the beam in and around the reconcreted void was not practicable (see Figure 7.1). Cathodic protection deep in the contaminated zone of the crossbeam would also have been difficult, requiring the drilling of many holes for embedded anodes. Removing the contaminated concrete would have been equally difficult, for while this could have been achieved in two separate halves, the full width of the crossbeam between the top and bottom mats of reinforcement was still required to carry torsion and to distribute load from the bearing locations.

<i>Flanking beams</i>	The flanking beams were to have been anchored into the existing beam beyond either end of the void by breaking out the top and bottom of the beam in the usual way for repair and casting in transverse dowels to carry the longitudinal shear between the existing and flanking beams.
<i>Shear strength</i>	Consideration was given to casting the flanking beams in the repair concrete used on the existing beam, but repair concrete has very small aggregate to assist its flowing characteristics, and there was concern that sufficient aggregate interlock would not be provided to carry the required shear through a full depth beam.
<i>Chloride migration</i>	There was also the risk of migration of chlorides from the contaminated zone of the existing beam into the flanking beam over the length alongside the void. A waterproofing membrane was proposed between the two beams between the top and bottom reinforcement mats to overcome this, the reinforcement mats being protected by the cathodic protection.

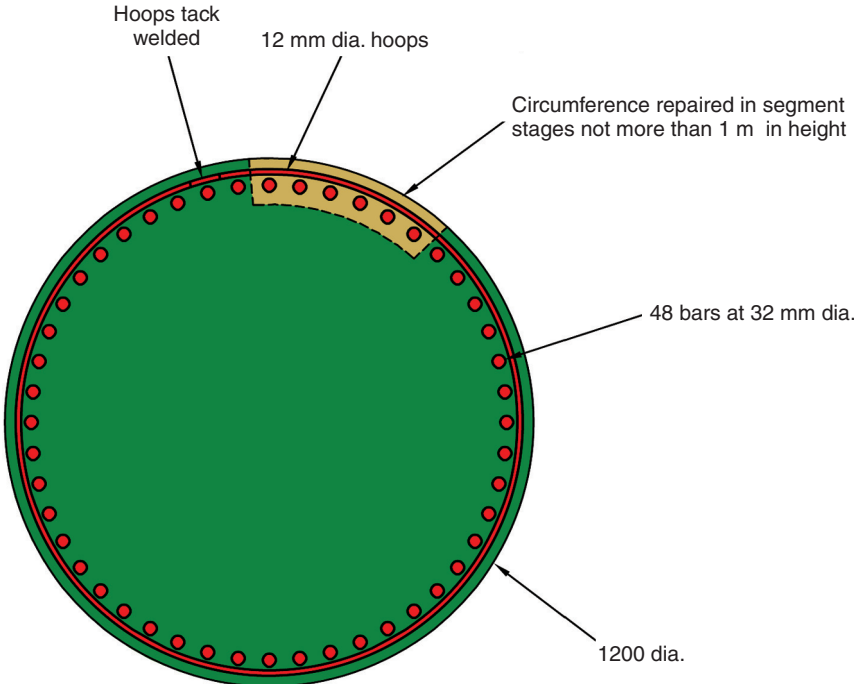
Figure 8.2 – Typical column repair sequence

Circular concrete columns, monolithic with crossbeams and experiencing salt water run-off through leaking deck joints, were found to absorb chlorides at the top of the columns. Presumably run-off from the crossbeam and columns soaked into the ground adjacent to the columns, for the bottoms of the columns were also found to be contaminated with chlorides, possibly by capillary rise from the surrounding ground. Most column delamination occurred at the tops and bottoms of the columns (see Figure 8.1).

Calculations were carried out to determine the proportion of the column perimeter which could be broken out to behind the vertical reinforcement such that the remaining encased reinforcement could carry the applied loads. Normally this was between an eighth and a quarter of the perimeter. The circumference at the top and bottom of the column was then broken out in sequence to enable repairs to delamination and to the reinforcement to be carried out (see Figure 8.2). The height of the repairs was determined by the safe height it was considered the repair concrete could be dropped down the repair area without fear of segregation, generally about 1 m. Columns supporting the same or adjacent crossbeams were not repaired simultaneously.

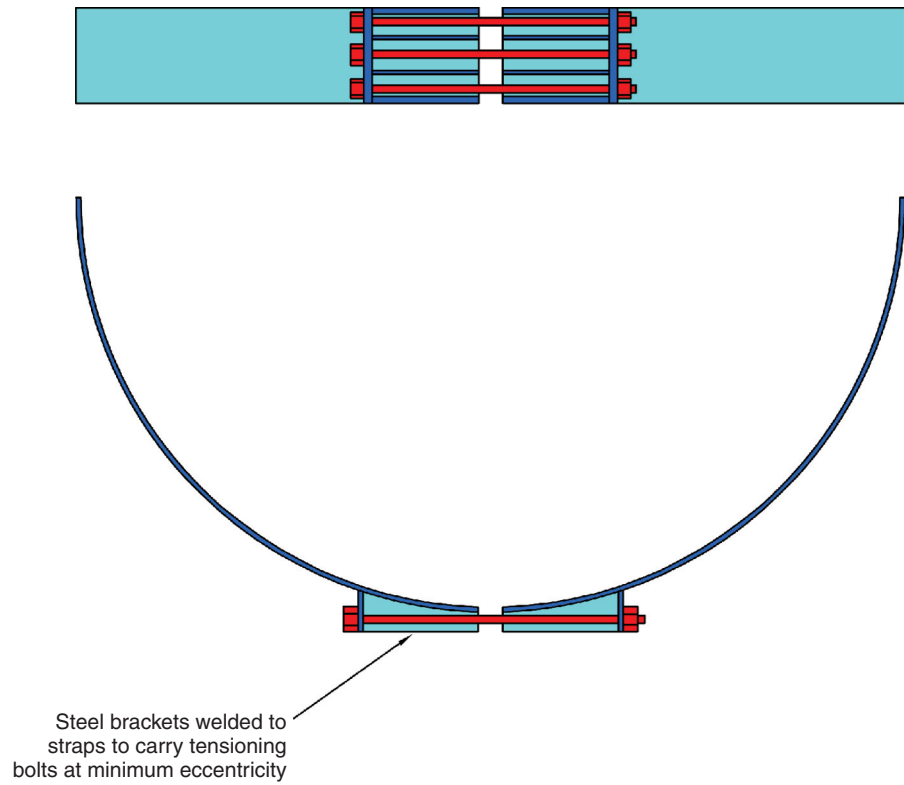
*Figure 9.2 – Steel column straps*

A strut and tie analysis was carried out to distribute the bearing line loading diagonally downward on to the centroids of the semi-circular segments below, in the case of the 1500 mm columns, and on to the centroids of the two semi-annuli below, in the case of the 2700 mm columns (see Figure 9.1). The horizontal tie forces, half-way down the hoop steel, required to restrain these diagonal struts then provided the forces in the hoop steel. The capacity of the hoop steel allowing for the estimated amount of section loss was found to be inadequate on a number of columns.

Temporary steel straps were then bolted around the column tops to compensate for the loss of strength. These were designed in the form of large jubilee clips, the bolts being set in brackets such that at the joint the bolts were recessed into the thickness of the strap to minimise eccentricity and hence minimise bending moment in the strap (see Figure 9.2). The straps were jointed at three locations to facilitate fitting to the column.

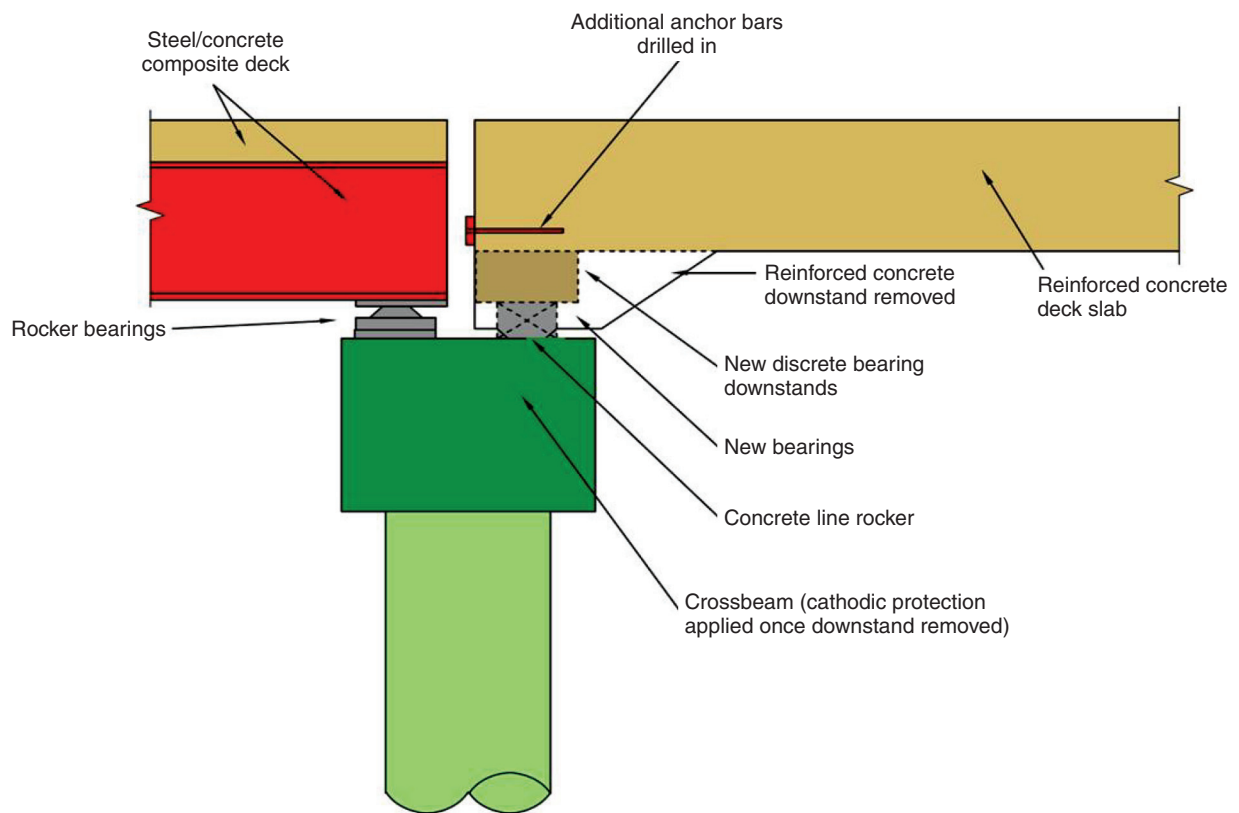
Figure 15.1 – Downstand replacement

A crossbeam supported a steel concrete composite deck span and a solid concrete slab deck span, the latter having a reinforced concrete downstand to make up to the depth of the adjacent composite deck. The crossbeam was impregnated with chlorides from the leaking deck joint above and it was proposed to replace the delaminated concrete and apply cathodic protection. However, the reinforced concrete downstand, in covering half the width of the top of the crossbeam, would preclude access and application of the cathodic protection. The decision was taken to remove the downstand and replace the simple downstand concrete line rocker with discrete bearings (see Figure 15.1).

Once the epoxy grout had hardened, the downstand was removed by water-jetting over lengths just sufficient to insert the new bearing. Prior to bearing installation, any delamination on the top of the crossbeam was removed and replaced with repair concrete, the crossbeam having been temporarily propped. There was sufficient height available to drill in anchor bars for the bearing downstand and holding down bolts to fix the bearing (see Figures 15.2 and 15.3). This process was repeated until all the bearings were installed, after which the remainder of the downstand between the bearings was removed, and the repair of the crossbeam completed.

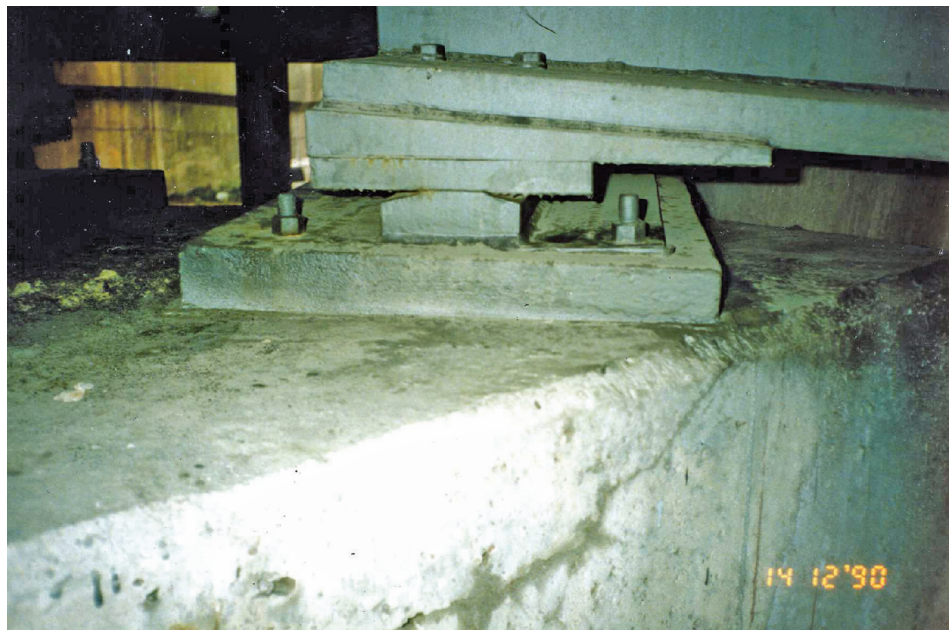
*Figure 15.5 – Steel rocker bearing. No bearing stiffeners*

The crossbeam supported the decks at a skew angle and the ends of the steel girders supporting the composite deck did not have bearing stiffeners (see Figures 15.4 and 15.5). A number of other crossbeams supported composite decks at skew angles, and calculations showed that bearing stiffeners needed to be added at all these crossbeams. The transverse forces at the deck ends were carried by reinforced concrete panel walls built on to the crossbeams at deck ends which were fixed longitudinally and by shear keys between the adjacent deck ends at those which were free to move longitudinally. At the free ends, the deck edge was supported by reinforced concrete stub columns, free to rotate about both longitudinal and transverse axes (see Figure 15.6).

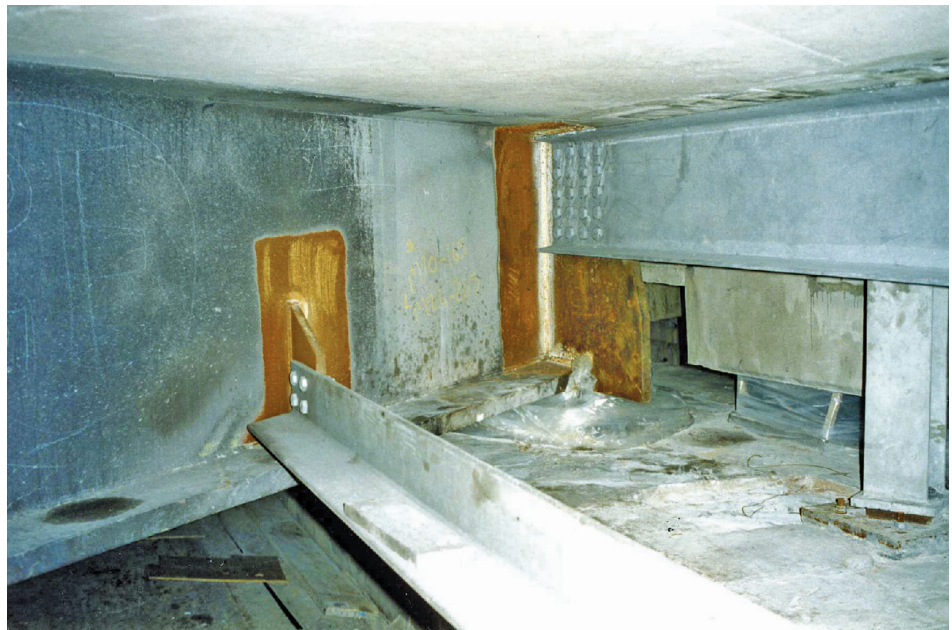
*Figure 15.8 – Bracing to bottom flange. (Also trimmer beam)*

The stub columns were severely corroded, the perimeter often being fully delaminated due to corrosion of the helical reinforcement, and the dowels into the deck sometimes being corroded right through (see Figure 15.7). On one crossbeam the stub columns had been temporarily supported on either side by hardwood props, with timber walings front and back. Although on a skewed support, the steel deck girders were supported on simple steel line rocker bearings, these being required to support the web in the absence of bearing stiffeners. However, calculations showed that this arrangement would become overstressed with the addition of bearing stiffeners, and the rocker bearings were therefore to be replaced with spherical bearings. These in turn required the bottom flanges of the deck girders to be braced (see Figure 15.8).

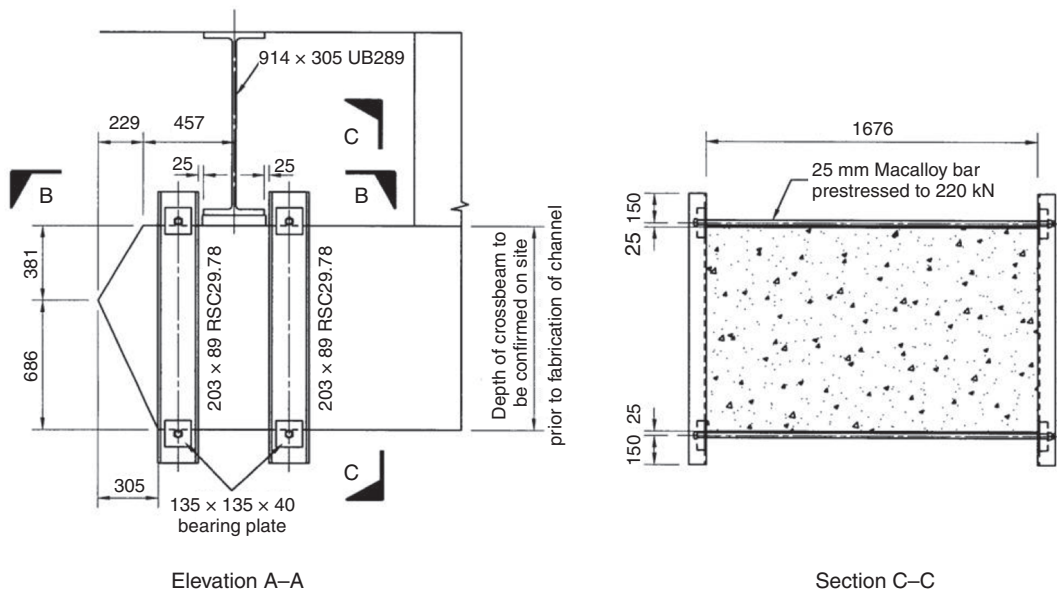
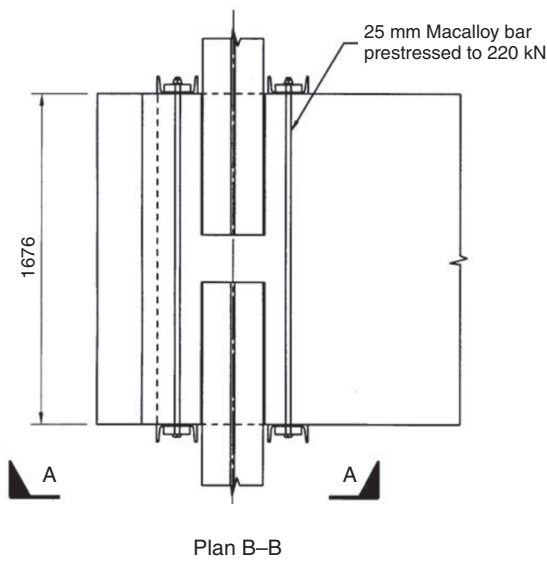
**Bent type 4A – strapping system**

A restriction in loading on the hard shoulder to 25 units of HB was already in place due to delamination of the cantilevers. The beam ends exhibiting cracking were not delaminated, however, and so the existing load restriction was able to compensate for loss of strength due to the cracking or ASR.

*Action* The hard shoulder was closed where the vertical crack was over 2 mm in width. Beam ends with vertical cracks 1 mm or greater in width were strapped transversely with steel channels braced with 25 mm diameter Macalloy bars either side of the deck edge beam, designed to withstand deck contraction forces transmitted to the bearings, assuming a bearing friction co-efficient of unity, to prevent the vertical cracks being pulled open (see Figure 20.2).
