FAILURES IN CONCRETE STRUCTURES

Case Studies in Reinforced
and Prestressed Concrete

Robin Whittle

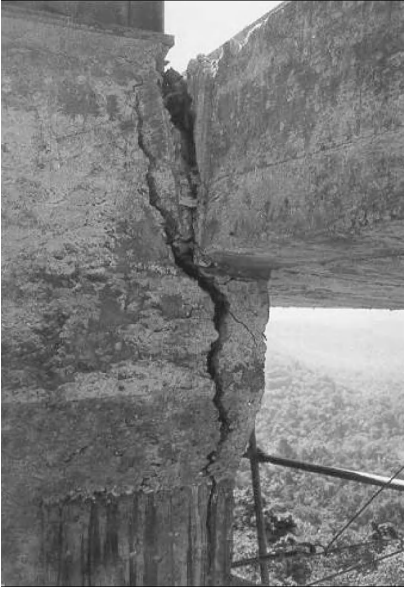
A collapse occurred involving the connection of a heavy concrete gutter (1 m wide) to the supporting columns. The structure consisted of a series of reinforced concrete edge columns supporting steel trusses that spanned the width of the building. Edge beams spanned between the columns to support the concrete gutter. Figure 1.1 shows the collapse of the gutter. Although the edge beam had been designed and detailed to resist the full load from the gutter (bending moment, shear, and torsion), this had not been carried through to the joint. Figure 1.2 shows where the edge beam just started to tear away from the column and Figure 1.3 shows the top of a column where the edge beam has separated and fallen off.

Figure 1.2 Edge beam starting to separate from column.

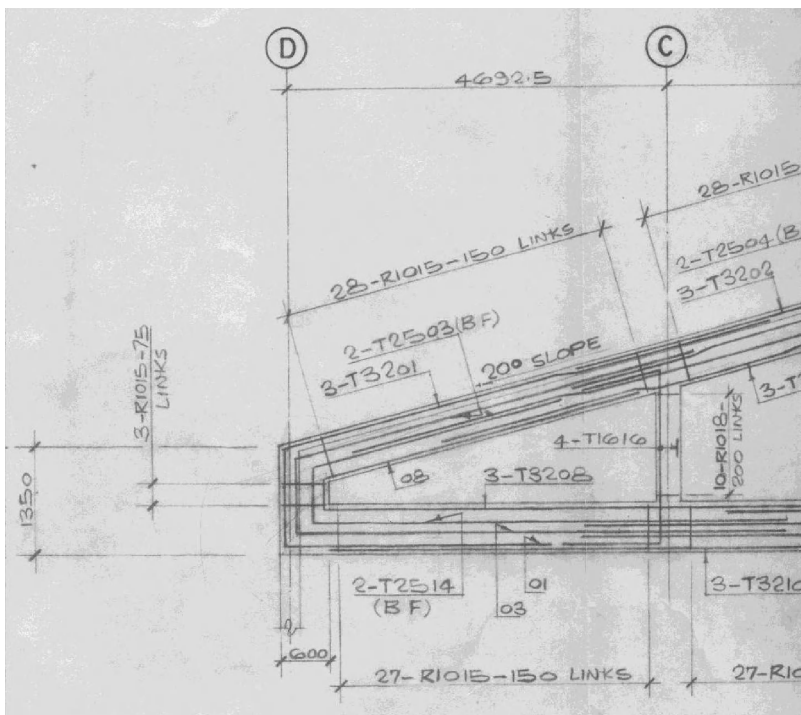
A project team requested a second opinion about the design of the bottom boom of a 19 m span reinforced concrete truss. The project team considered that the tension would cause unsightly cracking. A drawing (see Figure 1.6 showing the detail of part of the truss) and the analysis of the truss were provided. Much attention had been given to this design and special care had been taken to ensure that the stresses in the concrete were low.

Figure 1.6 Detail of part of truss.

It was also apparent that the detailing required some changes. Figure 1.6 shows the main T32 bars, drawn as if they could be bent with sharp corners when in fact the minimum inner radius of bend required ($3.5 \times$ diameter of bar) is 112 mm. When drawn to scale, it became clear that the concrete would fail in two places as shown in Figure 1.8.

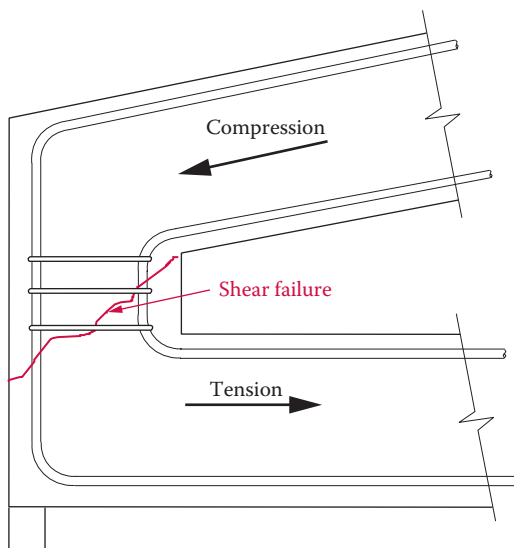
The request was to check the design of the bottom boom. This check was carried out and it became apparent that the shear strength of the end vertical post connecting the top and bottom booms (see Figure 1.7) was inadequate. The section dimensions were $b = 230$ mm and $d = 460$ mm.

Figure 1.7 Shear in vertical post at end of truss.

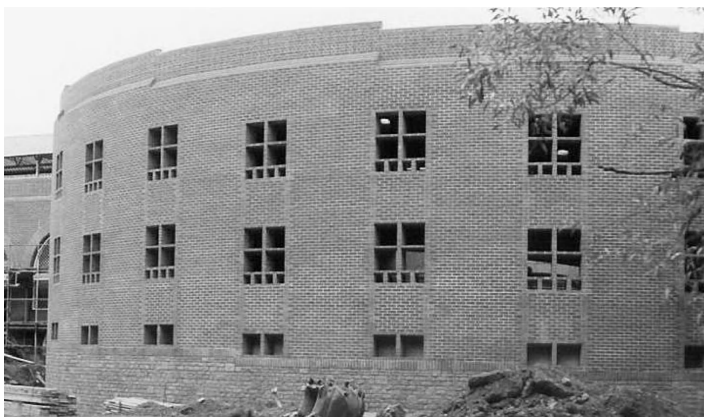
The construction of this car park (see Figure 1.9) was nearly complete. The parapet and slab of the circular ramps were supported on two columns diametrically opposite each other. The torsion and cantilever effects of the loads caused wide cracks in the supporting columns. Although these columns were damaged with shear cracks, it was considered that if the cantilever and torsional effects from the ramp could be reduced, then the columns could be repaired without risk that the cracks would return. This was achieved by inserting steel circular columns half way around at every level throughout the height of the structure (see Figure 1.10). In order to ensure that these new columns would take the correct load, flat jacks were introduced at each floor level (see Figure 1.11).

Figure 1.9 Car park with circular ramps.

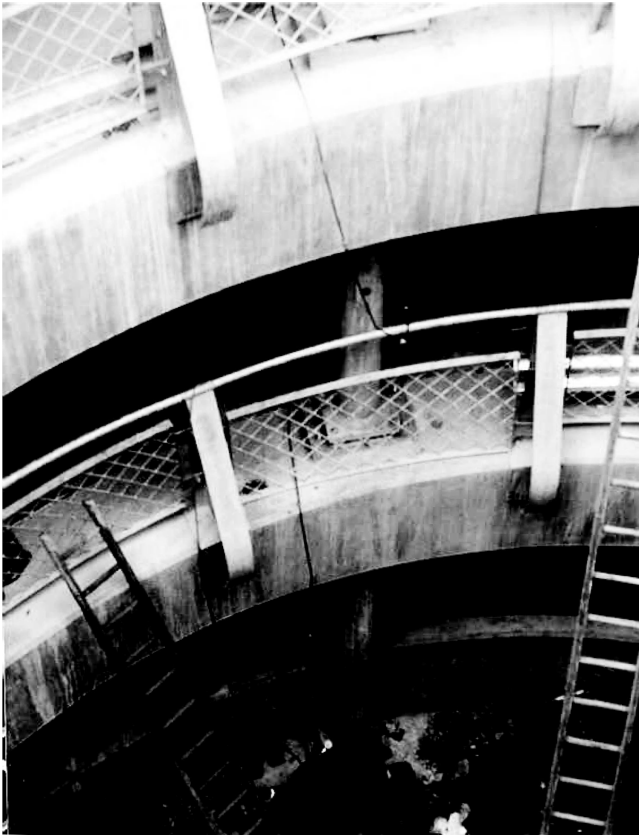
Figure 1.10 Additional steel columns.

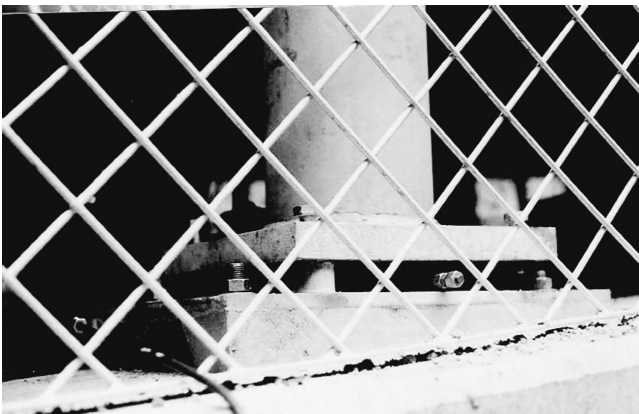
Figure 1.11 Flat jacks fitted under each new column.

All the flat jacks were connected up to a single pump and pressure gauge. Epoxy resin was pumped into each of the flat jacks at the correct pressure and allowed to harden. This ensured that the correct load had transferred to the new steel columns at each level.

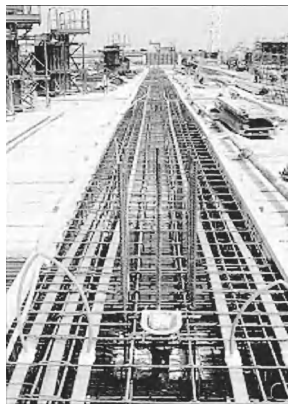
The construction period for the car park was extremely short (8 months) and hence all the prestressing work was carried out under a very tight schedule. Figure 1.13 shows a typical beam under construction.

Unfortunately, 5 to 6 days after the transfer of prestress for the first set of beams, cracks appeared in many parts of the frame. The cracking was

Figure 1.13 Typical beam under construction.

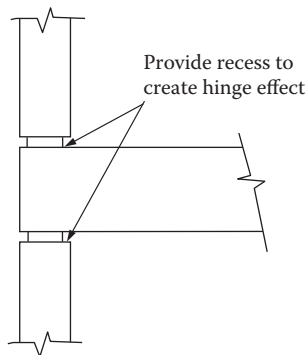
A concrete frame with a two-span prestressed beam had been designed for serviceability limit state (SLS). When checking the frame for the ultimate limit state (ULS), the designer discovered that the moments induced into the edge columns exceeded their capacity, 850 kNm. Figure 1.16 shows the layout of the structural model of the frame. The moments from the ULS analysis are shown in Figure 1.17. To reduce the transfer moment at the edge, the designer considered creating hinges between the column and slab as shown in Figure 1.18. This proposal was not favoured because:

Figure 1.18 Proposal for providing hinges.

- Reinforcement must be placed centrally to allow a hinge effect to be created.
- Compression in the concrete section would automatically create moment transfer.

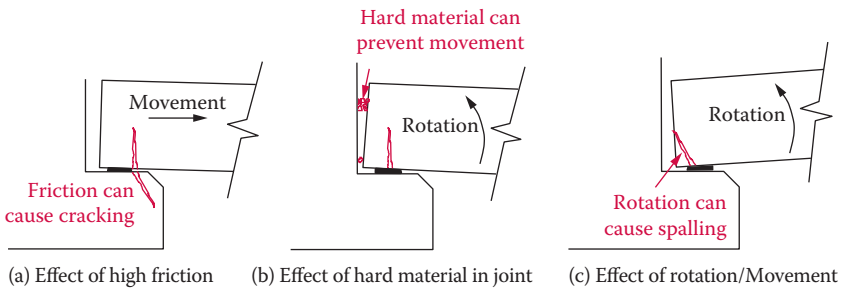
Figure 1.22 Examples of potential failures at movement joints.

In general, if the bearing material creates large friction forces, these can lead to large tension stresses in both the support and the precast slab or beam (see Figure 1.22a). Neoprene bearings or similar should be used to avoid this.

If the space between the precast slab or beam and the face of the supporting member is not adequate for the required movement or it fills with hard material over time, cracking will occur (see Figure 1.22 b). If the effects of movement and/or rotation cause the line of action to move too close to the edge of the support, local spalling can occur (see Figure 1.22c).

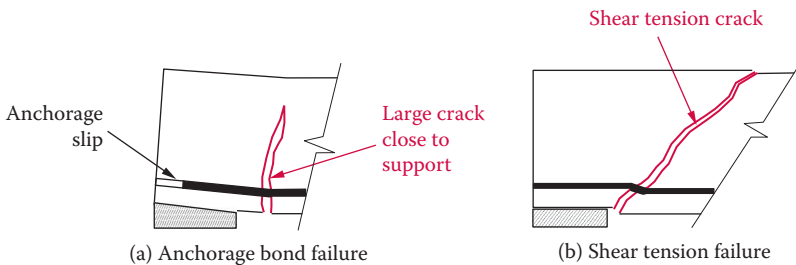
Figure 1.23 Types of end failure of hollow core units.

A further problem arises where hollow core units are used. Any cracking that occurs close to their ends is likely to cause anchorage bond or shear failure of the unit (see Figure 1.23). Anchorage bond failure may occur because the cracking close to the support does not allow the full anchorage resistance to develop and the prestressing strands start to slip. This causes the crack to grow until the unit fails (see Figure 1.23). Hollow core units are inherently vulnerable to the effects of cracking close to the support as their shear resistance relies on the tension strength of the concrete. Unlike a solid section, a cross section available for shear resistance of these elements is much reduced due to the presence of the cores.

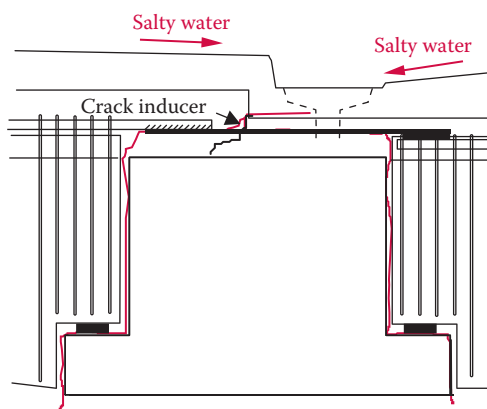
The structural screed laid over the whole deck was designed with a step over the welded plate above the spine beam. The final screed, incorporating a waterproof membrane, was laid to falls. The drainage points were situated at the ends of the spine beams. Figure 1.27 shows the final arrangement through a section. The step in the screed created a crack inducer for the tension stresses at the top of the cantilever and water draining off the

Figure 1.27 Section through completed deck.

car park was likely to permeate it. In winter, this water was likely to be combined with de-icing salts. The risk of corrosion of an important part of the structure was high. By the time this problem was realized, it was considered too late to change the design and form of construction. Instead the depth of the waterproofing membrane was increased.

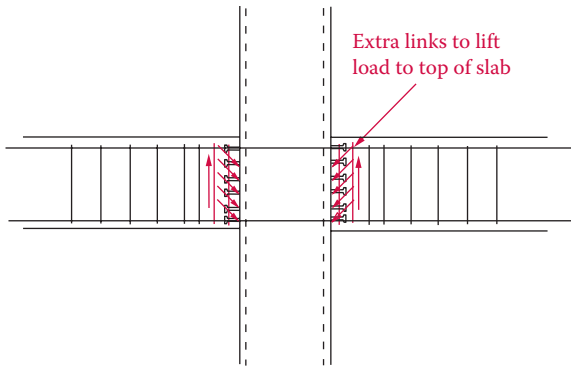
Figure 1.34 Use of links to transfer load to shear studs.

Option 1: Provide links to transfer the load back to top of slab — Links, in addition to those required to resist punching, would be required to transfer the full load to the top of the slab. Struts in the concrete would then transfer the load on to the shear studs (see Figure 1.34). This is unlikely to provide the most practical option.

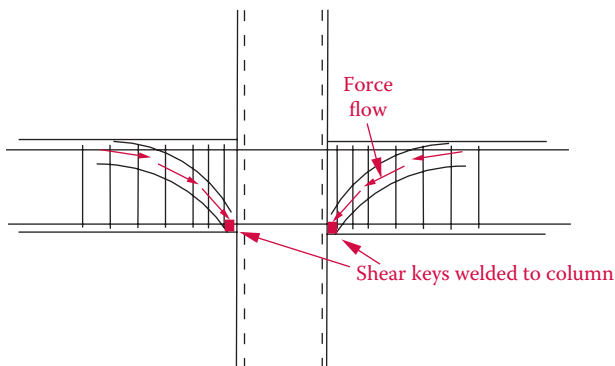
Figure 1.35 Use of strut-and-tie model to transfer load to shear key.

Option 2: Provide shear key (instead of studs) at bottom of slab — Using a shear key with full strength welds at the bottom of the slab would provide adequate resistance. The shear links would ensure against a punching failure and the resulting force flow would engage the shear key (see Figure 1.35). The size of the shear key would depend on the thickness of slab and the shear force. The upper limit to this solution would be the compression strength of the concrete at the column face:

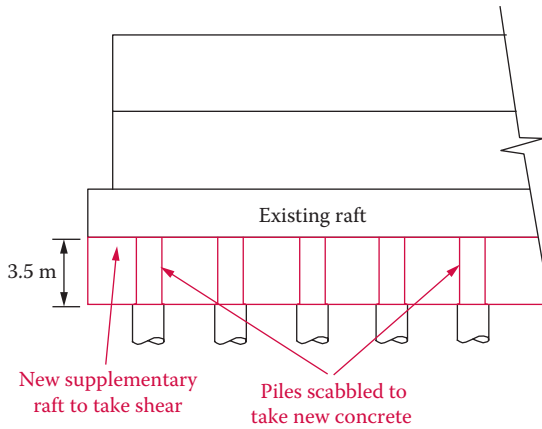
Figure 1.37 Schematic arrangement of new raft.

The mistake was discovered whilst the tower block was being constructed. The remedial work required a new raft to be constructed beneath the existing one (see Figure 1.37). The new design relied on the composite action of the new and old rafts. All the existing surfaces of concrete were scabbled and further reinforcement was laid between the existing piles. Placing of concrete for the lower part of the new raft was carried out conventionally.

To achieve good bond with the bottom of the existing raft, the upper part of the new raft was packed with single sized aggregate and then grouted with a retarded and fluid cement paste. The grout was introduced under pressure to the back of the pour through a complicated system of metal pipes pinned to the underside of the existing raft. The method produced a wall of grout that extended from top to bottom of the pour and flowed forward toward the peripheral shutters with the top surface behind the bottom. Pipes were so placed to let the air out in front of the grout surface, then indicate where and when the grout arrived, and then allow grouting to continue from immediately behind the advancing wall of grout. Grouting was continuous until the work was complete.

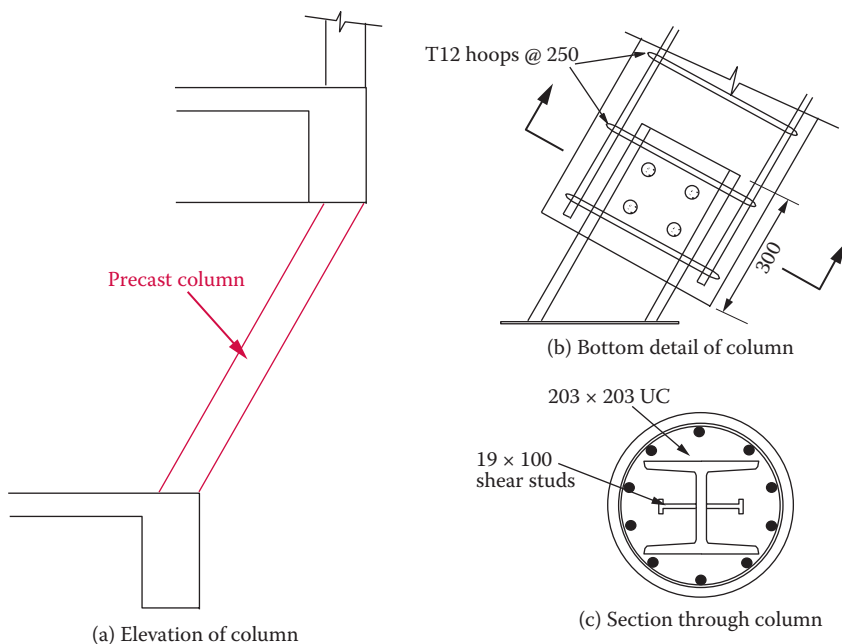
Figure 1.38 Sloping precast column.

into the bottom of the precast element to simplify the connection detail to the beam below. During construction, it was realised that the design of this connection was unsafe due to insufficient bond capacity and anti-bursting steel.

The short stub consisted of a 254 × 254 UC section that extended into the column about 300 mm. The stub had four 19 × 100 shear studs welded to each face of the web (see Figure 1.38b). The links surrounding the stub column were T12 hoops at 250 mm pitch. No other anti-bursting reinforcement had been provided.

No calculations had been carried out to determine the required embedment length of the UC stub column. Bond and end bearing should have been considered.

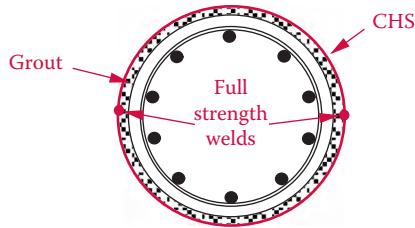
Figure 1.39 Remedial work.

The remedial action was to encase the existing column with a steel circular hollow section, 457 mm diameter, of the same length. This was cut into two halves along its length and then welded in place with full strength welds along the full length. The space between the steel and precast columns was then grouted up (see Figure 1.39).

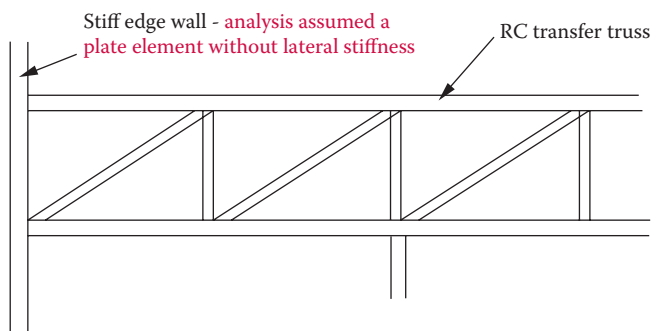
The second check revealed that the initial design of the concrete truss involved the use of a complicated finite element program. The end support to the truss was a stiff wall and this had been modelled with plate elements that had no lateral stiffness (see Figure 2.1). The second consulting engineer then carried out separate frame analyses with simpler programs that included more realistic properties for the edge wall. The results showed that the design of the trusses was safe—just. The reinforcement details of the nodes required some minor changes.

Figure 2.1 Diagrammatic view of concrete truss.

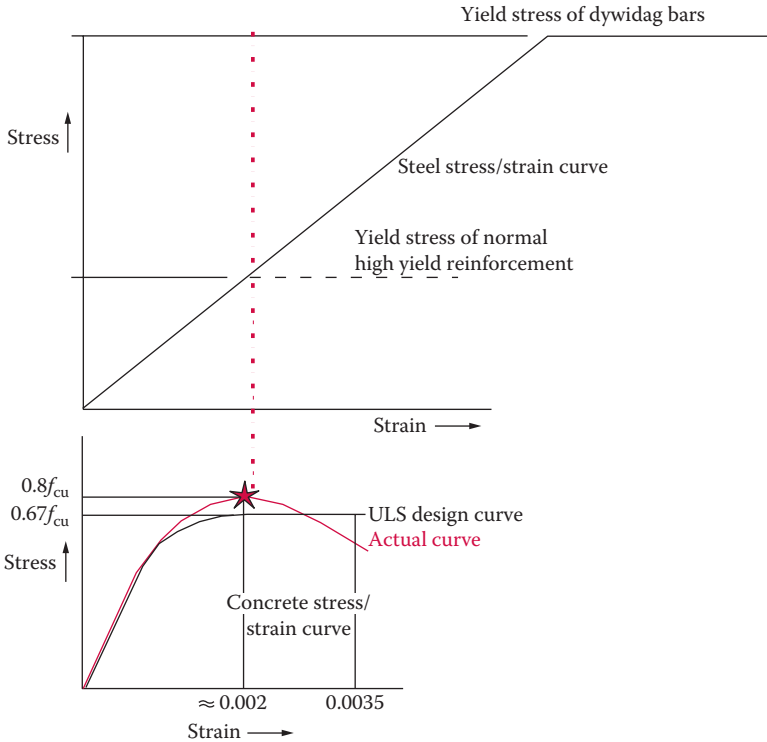
Figure 3.4 Stress–strain curves for concrete and steel.

The yield stress of a Dywidag bar is about 1200 MPa which corresponds to a yield strain of $1200/200000 = 0.006$. This compares with the ultimate strain of the concrete of 0.0035, so the concrete will fail in a compression test long before the Dywidag bar reaches its yield strain or stress. Figure 3.4 shows this graphically.

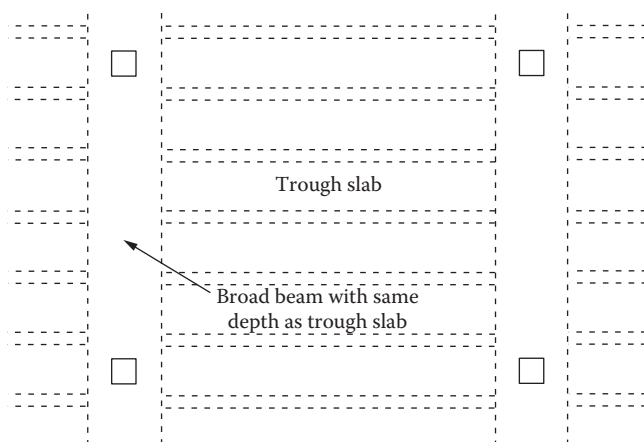
Figure 4.1 Plan view of trough slab.

Several buildings of a university included ribbed floor construction (see Figure 4.1). The ribbed slab was designed as a simply supported element spanning between edges of a broad beam. The curtailment of the longitudinal reinforcement in the ribs was in accordance with the code clause stating that, ‘each tension bar should be anchored by one of the following: ... b) an effective anchorage length equivalent to 12 times the bar size plus $d/2$ from the face of the support...’ In this case, the curtailment was measured from the edge of the broad beam. Top reinforcement in the slab was provided in the form of a structural fabric.

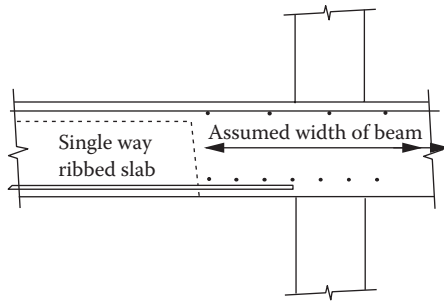
Figure 4.2 Section through broad beam.

The depth of the broad beam was the same as the trough slab and the design wrongly assumed that it could be considered a one-way slab and therefore did not require links (see Figure 4.2).

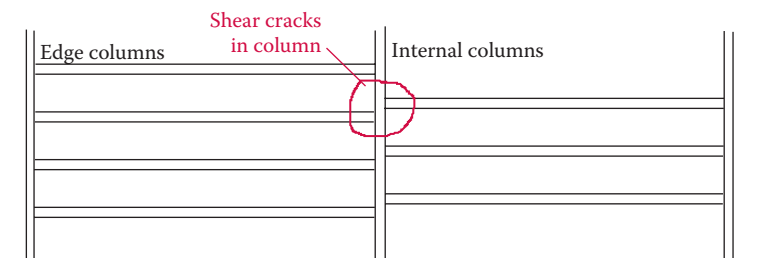
Figure 4.4 Structural elevations of beams and columns of car park.

Figure 4.4 shows the beams on the sides of the internal columns. They are stepped to allow ramping between levels (as is often the case). The internal columns were much stiffer than the edge columns and in consequence the support moments and shear forces within the column were high compared with the edge columns. The column shear forces caused large shear cracks (up to 2 mm) within many of the columns.

Although a failure mechanism was not present, a problem occurred from repairing the cracks. As soon as the car park filled with vehicles after the repair, the cracks reopened and eventually the deterioration of the column concrete could have led to a collapse.

The design had been carried out to the existing code of practice of the time which did not have specific clauses for shear in columns. By the time remedial work was carried out, new code clauses in place required shear checks of columns. The design of this particular joint was inadequate to the new clauses. The insurance company required remedial work to be carried out so that the building would comply. This was considered to be so costly that the decision was made to demolish the existing structure and replace it with a new design.

Comment — Although the existing design code did not cover this particular situation, the designer should have been aware of the problem and taken action in the design to prevent overstressing within the joint. This is an example of common practice in the 1960s and 1970s when many engineers extrapolated the existing clauses of the codes of practice for situations outside the scopes of the codes.

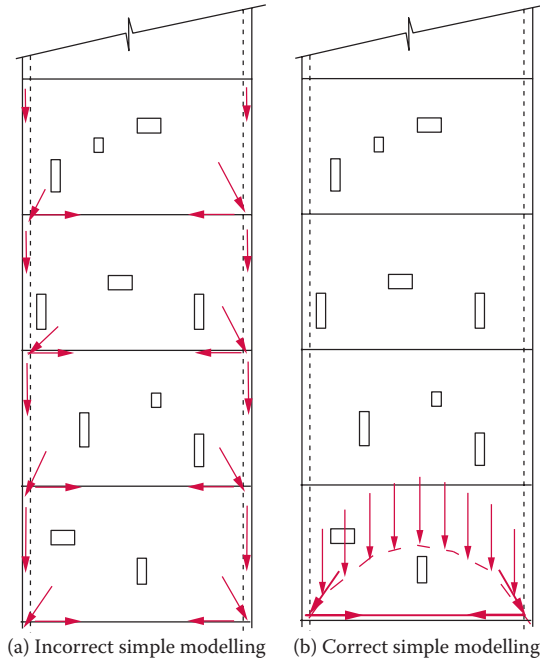
Figure 5.4 Multi-storey shear wall.

A multi-storey shear wall required so many openings (windows, doors, etc.) that the load path became very complicated. The designer assumed that the load would flow to the corners and then track vertically down the edge of the wall (see Figure 5.4a). In fact, since the wall was built in situ as a homogeneous structure, strain compatibility caused the load to flow back into the full width of the wall. The result was that several storeys of load

were supported by a deep beam that transferred the load to its end supports (see Figure 5.4b).

The limiting height of the natural arch of a deep beam ($0.6 \times \text{span}$) was not considered (see Figure 5.4b) and this resulted in the omission in the design of much of the reinforcement needed for the bottom tie. Construction had reached several floors up by the time the mistake was recognised and this led to a redesign of the wall during construction and heavy remedial work. Each part of the wall required careful re-appraisal. This led to the requirement of much more reinforcement at each floor level. The bottom corner reinforcement details required special attention to ensure that the junction between the tie and compression struts was adequately designed.

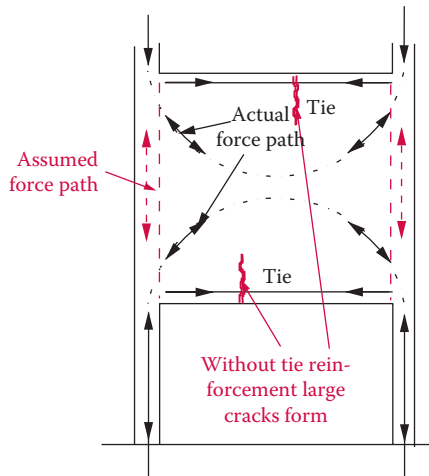
Figure 5.5 Modelling deep beams.

Figure 5.5 shows in a simple diagrammatic form how the force paths automatically flow out and back again. The assumed force path down the edges would not require ties at top and bottom, but without these the actual force path would cause large cracks to open up from the top and bottom surfaces. Even after cracking, the angle struts would still exist and so would the consequential horizontal component. Without sufficient tie force to resist, the support joint would move outward and eventually failure would follow.

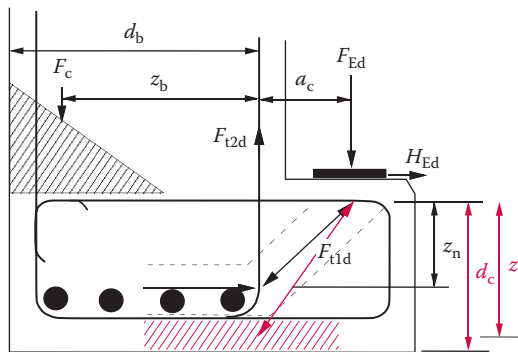
Figure 5.6 Nib attached to bottom of a beam.

Where nibs are attached to the bottom of a beam it is important to understand the load path of the forces. Figure 5.6 shows a typical section of such a nib.

The conventional assumption for a short cantilever of d_c and z_c (shown in red in Figure 5.6) is unsafe for such a nib. The design compression zone for such a model would be close to the bottom face of the beam and likely to fall outside the beam reinforcement (both the links and main reinforcement). Strut-and-tie modelling is helpful to explain why this is so. The strut (shown in red in Figure 5.6) would just cause the cover to the reinforcement to spall off. The strut must be supported mechanically by the reinforcement of the supporting beam (shown in black in Figure 5.6). The effective lever arm becomes much smaller and the tension force in the nib top reinforcement much larger than assumed by the short cantilever approach.

It should also be noted that the force in the supporting links of the beam, F_{t2d} , is likely to be much greater than the applied load on the nib, F_{Ed} , to satisfy equilibrium. For the situation shown in Figure 5.6, it is conservative to assume the compression acts at the centroid of a triangular compression stress block. Hence the force in the link, in addition to any shear, may be calculated as follows:

Comment — There are probably many nibs of this type that have been designed incorrectly and survive because of built-in safety factors and the fact that the load assumed in the design has not occurred.

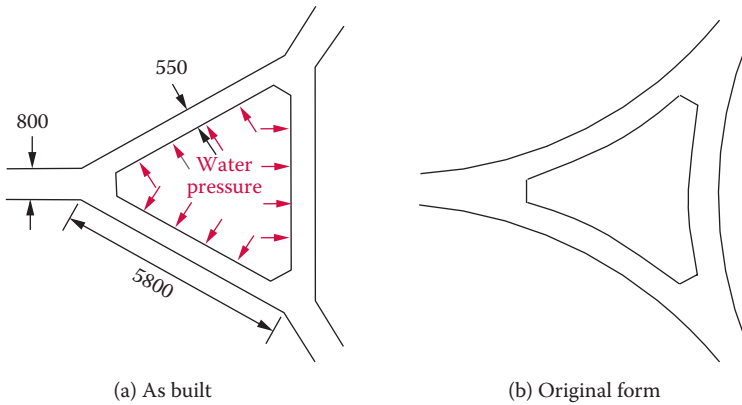
Figure 6.3 Detail of tri-cell.

Figure 6.3 shows a detail of the tri-cell wall that was designed to resist the water pressure when the cellular base was submerged. Figure 6.3b shows the original form of the cells with cylindrically shaped walls. The natural arch action provided by that geometry was not present in the modified form shown in Figure 6.3a.

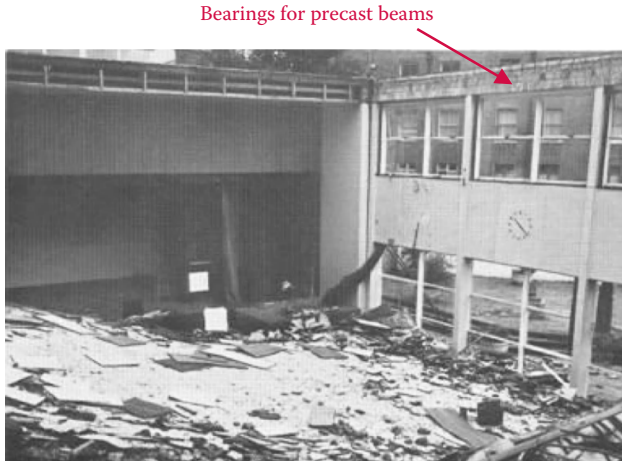
The principal cause of the collapse was inadequate bearing for beam seatings and deterioration of concrete at beam ends. The hall was one of the first buildings found to have suffered from the effects of high alumina cement (HAC; see Section 7.4).

Comment — This was an example of inadequate design and poor detailing of the end bearing nibs built into the supporting beam for the precast beams. The reduction in strength caused by HAC left no margin for temperature effects. The combination was likely to have triggered the collapse.

Figure 6.5 Assembly hall showing edge beam that supported the precast beams. (From Scott, G.A., *Building Disasters and Failures*, Construction Press Ltd., Lancaster, 1976. With permission.)

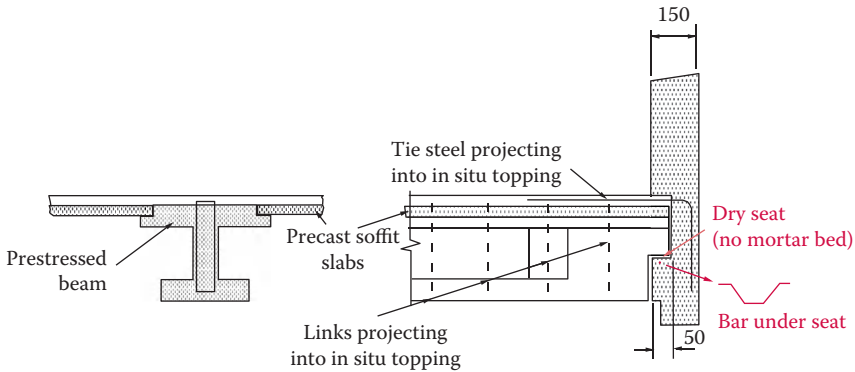
Figure 6.8 Prestressed beam and support.

The roof was constructed of prestressed precast concrete beams made with HAC spanning 12.6 m, supporting precast concrete slabs acting as permanent formwork for an in situ concrete topping (see Figure 6.8). The outer ends of these beams rested in 50 mm deep pockets cast into the vertical inside faces of the edge beams. In addition to these, the edge beams had recesses just below their seatings. These encroachments on the already narrow section led to the adoption of a reinforcement arrangement that had no main steel under the seating pockets for the prestressed beams.

The cause of this collapse was a disastrous combination. The columns and edge beams were precast as T units (with webs facing outward). The architect had, in order to obtain a dark colour, specified HAC concrete to be made with aggregate that was highly alkaline. The specification had been mistyped or misread to call for one part HAC to four parts sand to two parts aggregate (these mix proportions were confirmed by analysis after the event). Cores drilled from one of the T units after the collapse revealed strengths as low as 7 MPa and some could not be extracted in one piece.

The depth of seating for the pretensioned roof beams satisfied the code requirement for bearing pressure, but left no margin for erection tolerances or temperature effects. There was inadequate reinforcement detailed under the beam seatings, and as the T units were cast with external faces down, even that reinforcement was displaced downward, away from the seating ledge.

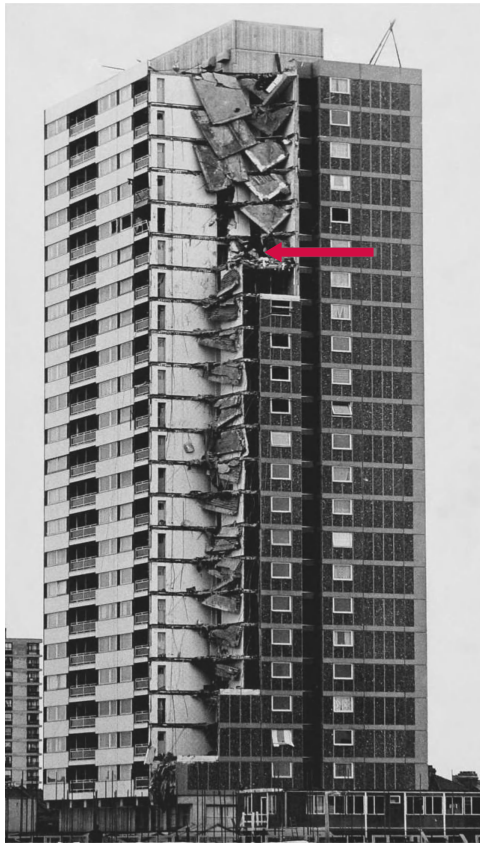
In the early hours of 16 May, 1968, a gas explosion in a bathroom on an upper floor shook a building, resulting in the instantaneous collapse of part of one wing (see Figure 6.10). Four people were killed. Figure 6.11 shows a closer view of the upper floors after the explosion.

Figure 6.10 Progressive collapse showing point of explosion. (Ronan Point building collapse, May 16, 1968, London. Courtesy of Building Research Establishment.)

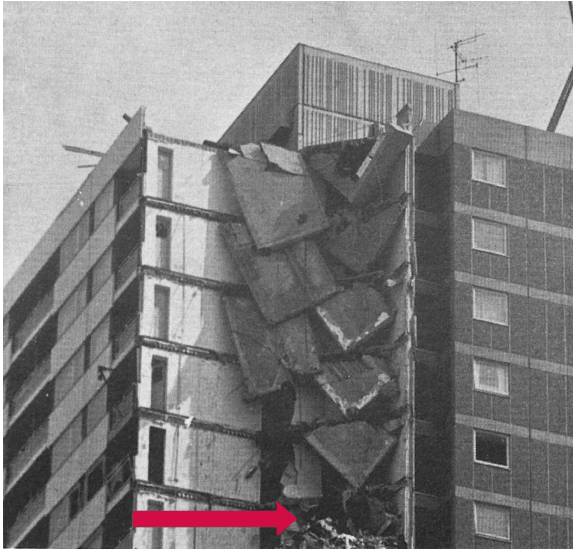
Figure 6.11 Closer view of upper floors showing point of explosion. (Ronan Point building collapse, May 16, 1968, London. Courtesy of Building Research Establishment.)

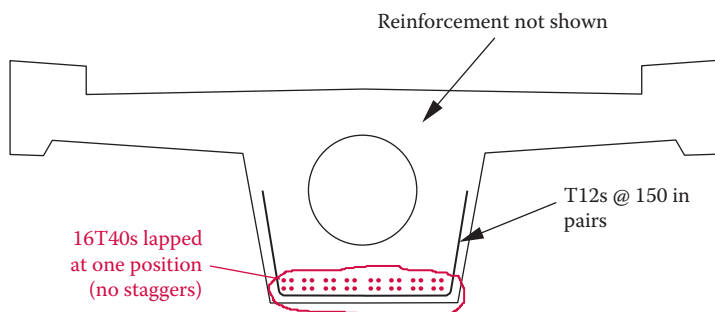
Figure 6.12 Section through footbridge.

A footbridge was being constructed over a motorway. The bridge had two spans with an in situ concrete T-section deck (see Figure 6.12). The span lengths were 20 and 40 m. After removing the formwork and props, two large transverse cracks (2 and 3 mm) appeared in the sides and soffit of the longer span. The cracks occurred at the positions of the laps of the main bottom reinforcement.

The reinforcement had been detailed so that all the main bars in the bottom, 16 T40s, were lapped at positions of high stress. It is generally considered poor detailing practice to lap bars in positions of high stress and lapping

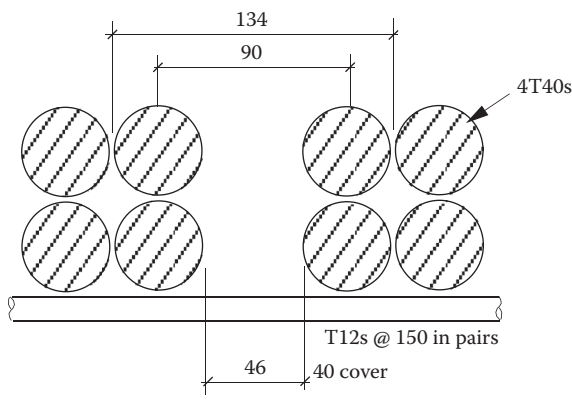
Figure 6.13 Layout of bars at laps.

all the bars in a congested situation compounds the error. The bars were cranked to allow them to be as close as possible (see Figures 6.13 and 6.14). Links, T12s @ 150 in pairs enclosed all the main bars. No extra links were provided at the laps or cranks.

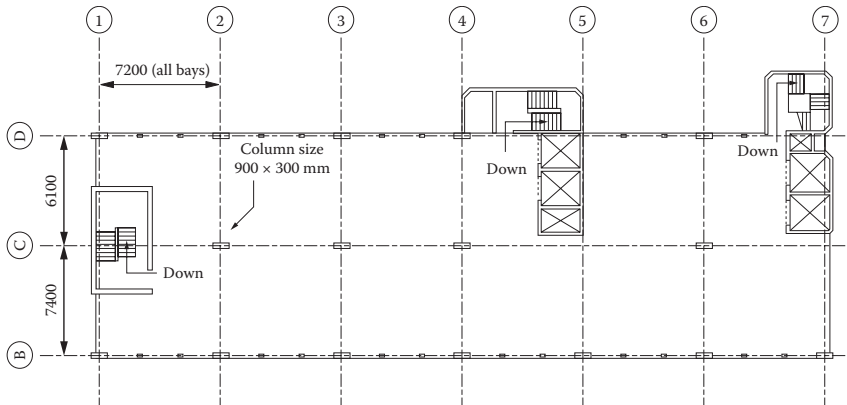
Figure 8.1 Structural layout of hotel floor.

Figure 8.1 shows the structural layout of a typical flat slab floor. The depth of the slab was 250 mm. The spans along the building were 7.2 m and across the building were 6.1 and 7.4 m. The top surface of the slab was very uneven and did not appear to have been levelled (by hand or power float). In some places, boot marks had been left. Cracks (generally not larger than 0.3 mm width) occurred on the upper surface radiating from the corners of the columns with one or two small cracks running tangentially. Large cracks (up to 1 mm width) appeared at some of the construction joints. The deflection of one of the slab bays of an upper floor was large—over 75 mm.

Excessive deflection — In order to understand how the excessive deflection had come about, it was necessary to check not only the design, but the in situ concrete strength, reinforcement details, and cover to the reinforcement as built. This check found that the only factor not as specified was the top cover to the reinforcement near the column supports. This was found to be on average 30 mm more than specified. This reduced the moment of

resistance at the support. However, after reasonable moment redistribution was included in the calculations, there was sufficient overall moment capacity in the slab without requiring any reduction to the design safety factors.

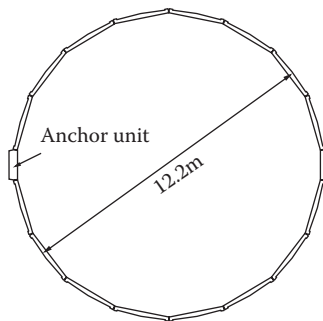
Figure 8.5 Precast elements of tank.

A liquid storage tank was constructed with precast wall panels. The diameter and height of the tank were 12.3 and 7 m, respectively (see Figure 8.5). The vertical panels were held in place by unbonded prestressed tendons threaded through horizontal PVC ducts embedded in the concrete and fully encircling the tank at set levels throughout the height. The tank collapsed without warning within 2 years of construction. Failure was caused by a number of separate mistakes.

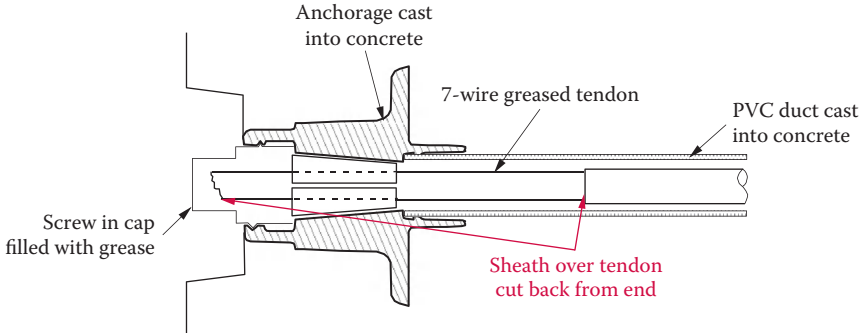
Figure 8.7 Detail of anchorage zone.

Sheathing and grease — The sheath and grease provided a continuous covering of the tendons up to the anchorage zone. In order to attach the prestressing jacks and insert the wedges, the tendons were stripped of the sheathing for some distance (see Figure 8.7).

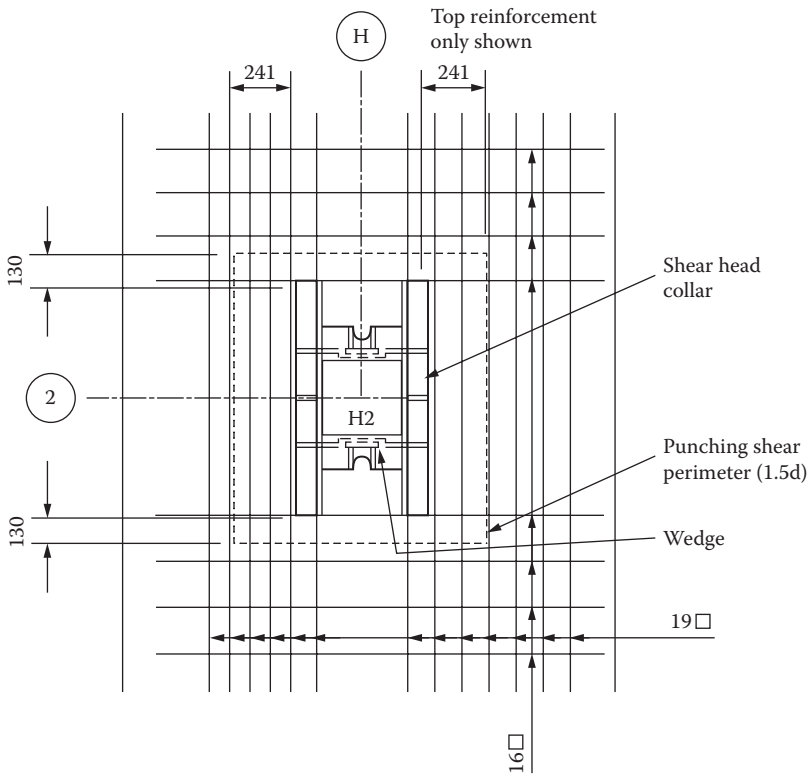
Figure 8.9 Plan layout at column.

The car park was constructed using the lift slab method. This involved casting the slabs one on top of another on the ground. Precast columns were positioned and then the slabs were jacked up the columns to the correct level. Final connection between the slab and the column was made via a steel collar in the slab and a steel insert in the column into which wedges were fixed. The steel collar supported the slab on angles that either formed a square or an H in plan. Figure 8.9 shows the typical H configuration used for internal columns. The column connection is very different from that found in a typical flat slab.

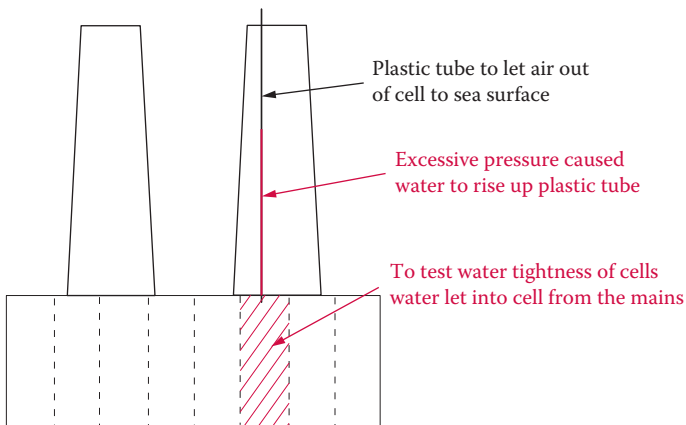
Figure 8.12 Water tightness test during construction.

were made during construction to test the water tightness of the cells. The intention was to fill each one of the cells to its top only. Each cell was constructed with a plastic tube that led to the top of the shafts to allow air to escape from the cell when it was filled during the final installation. The main water supply used to fill cells was capable of providing a pressure much more than that required, and the water level was allowed to rise up the plastic tube (see Figure 8.12).

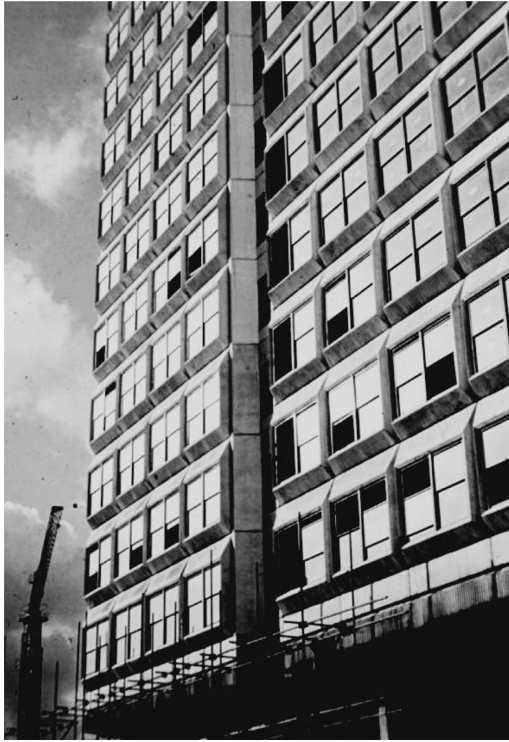
Figure 8.16 Office block with sculptured panel facades. (Courtesy of Poul Beckmann.)

The facades of a tall office block were made of precast concrete sculptured panels (see Figure 8.16) and incorporated load bearing mullions. The horizontal panels and mullion joints were about 600 mm above the floor level. It had been specified that the panels be levelled by means of steel shims and then mortar beds be laid to a level just proud of the shims. The panels with the mullions attached would then be lowered down onto the beds with the intention that the load would be shared between the mortar and shims.

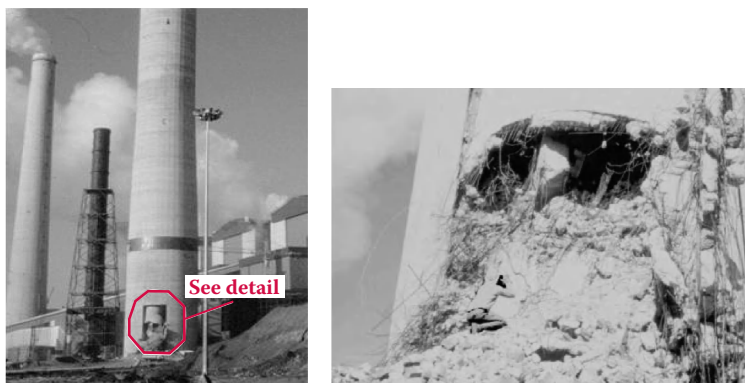
Figure 8.20 Debris from collapsed flue. (Courtesy of Alan Steele.)

Above the roof slab at the top, the flues were also clad externally with brickwork. The bricklayers had just finished capping the last flue when a fracture lower down caused the top half of one of the flues to slide down, disintegrate, and fill the bottom of the wind shield with debris that spilled out of the portal for that flue. One worker was killed (see Figure 8.20).

It was still possible to enter the chimney space through one of the other portals, and the inside of one of the intact flues could be examined. A substantial horizontal crack was found on part of the wall surface; inserting a knife blade into the crack indicated that the fracture surface sloped upward. Subsequently, more cracks of a similar nature were found on the inside of the wind shield.

The fracture surfaces on the concrete fragments in the debris seemed more square and sharper than expected. This was later explained as a feature of sudden disintegration of high-strength concrete by impact, as opposed to the slow failures observed in laboratory tests. Cores were taken

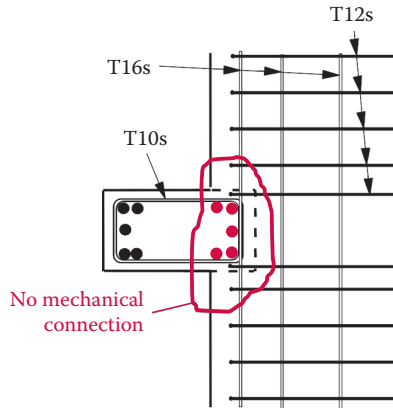
Figure 9.3 Actual layout of reinforcement.

The reinforcement arrangement intended for this joint is shown in Figure 9.2. Construction reached the second floor when a young graduate visited the building to gain some site experience. He reported back his concern about the reinforcement layout along the edge of the slab that was about to be concreted. Figure 9.3 shows what he saw. There was no mechanical link between the slab and the column reinforcement! It was immediately realised that not only had this occurred at all edges of the slab on the second floor, but also on the first floor that was completed several weeks earlier.

Comment — One of the reasons this situation occurred was that no check had been made in the design office to ensure that a mechanical link could be made. In fact, when the cover and the actual size of bars were taken into account, it was clear that the reinforcement could not fit as intended. The fabricator of the reinforcement fitted the bars as close to the correct position as possible without thinking that a mechanical link was essential.

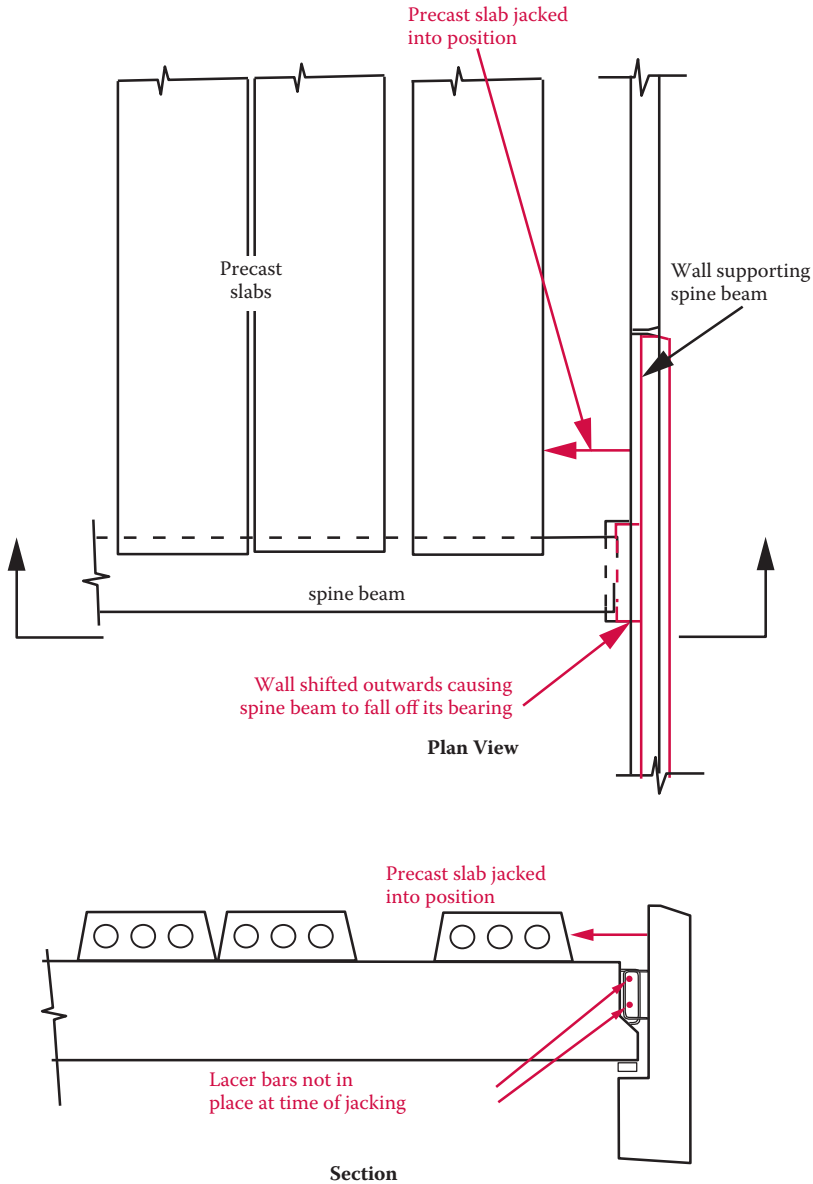
Figure 9.5 Adjusting positions of precast planks.

A spine beam carrying precast planks lost its bearing because a labourer trying to jack one of the final planks into position actually levered out

the wall panel supporting the end of the spine beam (see Figure 9.5). This caused the spine beam to lose its bearing and led to the collapse of the floor. The connection between the spine beam and the wall panel had been designed to have two overlapping U bars locked together with lacing bars threaded through the space between them. These lacer bars had not been inserted at the time of erecting and laying of the floor elements. If they had been in place, they would have prevented the wall panel from moving away from the spine beam.

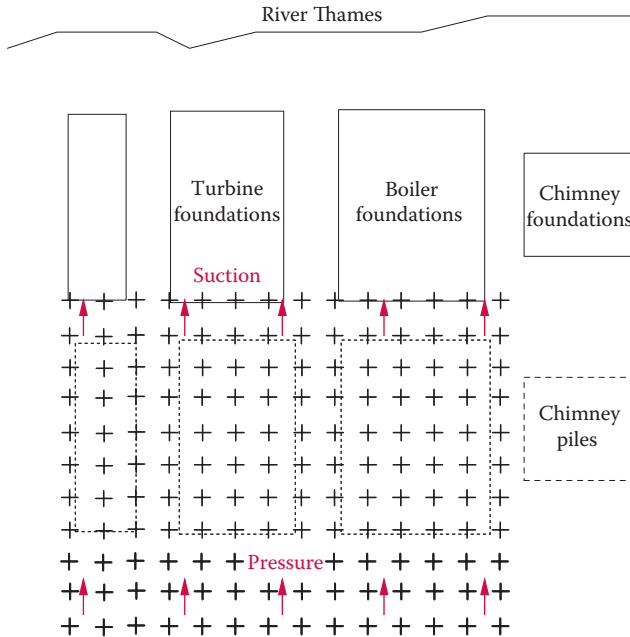
Figure 10.3 Diagram showing cause of movement.

A year after the start of piling, when concreting of the foundations progressed about a third of the way along the site, it was discovered that the tops of the piles that were still exposed were moving. *Measurements showed that the movement was up to 1.5m!*

The first major concern was to check whether the piles were still intact. One pile was extracted. It came out straight and appeared undamaged. On close examination, fine cracks could be seen throughout its length. This indicated that it had bent evenly over its full length.

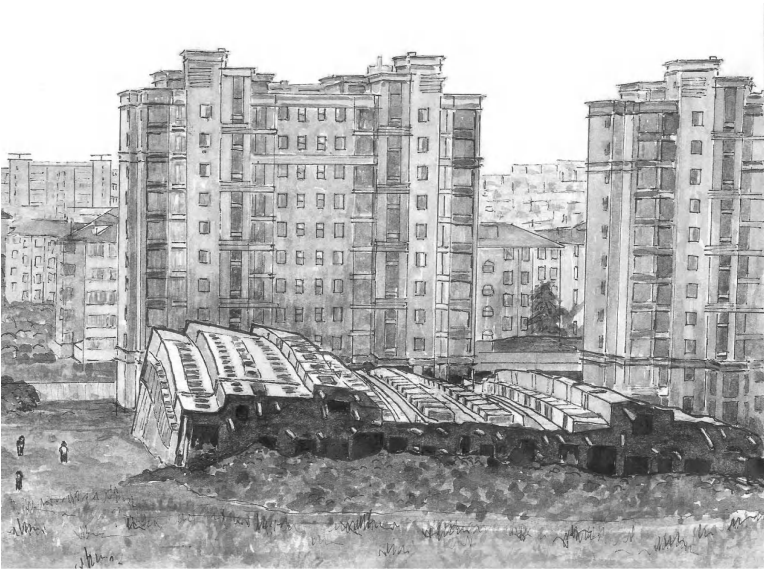
Figure 10.7 View of underside of collapsed building. (Courtesy of Gillian Whittle; redrawn from Reuters, <http://www.telegraph.co.uk/news/worldnews/asia/china/5685963/Nine-held-over-Shanghai-building-collapse.html>.)

It was very fortunate that the other tower blocks were not close enough to cause a domino effect. Figures 10.7 and 10.8 show how close this tower block was from its neighbours. Figure 10.8 shows a close-up view of the piles that failed in shear. The piles were made of circular hollow unreinforced concrete. They were constructed with short lengths at the top with solid reinforced sections (see Figure 10.9).

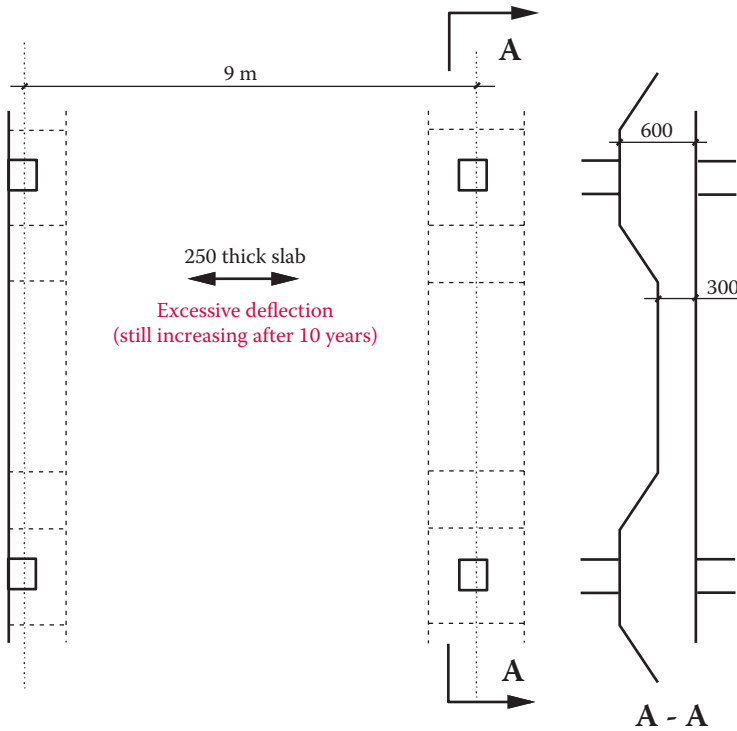
Figure 11.1 Plan and section of typical end bay.

The building in question was a telephone exchange built in the mid-1970s, 10 years earlier. Figure 11.1 shows a plan and section of a typical end bay. The slab had been designed as single way spanning between two shallow haunched beams. The design included a span of 9 m with a slab only 250 mm thick which many engineers would consider too thin.

The visit to site included the inspection of the slab close to a column. The screed had been removed to expose the top surface of the structural slab. On close inspection, the reinforcement appeared to be badly rusted and breaking through the top surface. As a crude check of the hardness of the concrete surface, it was scratched with a penknife. Quite unexpectedly, the blade of the knife penetrated into the concrete surface right up to the hilt! A further check of the soffit of the slab gave a similar result.

diameter) that were separating from the surface. One such piece came away as it was being examined. Although the slab had been designed to span one way, the supporting beam was sufficiently flexible for the slab to behave more like a flat slab. The ‘flying saucers’ appeared in the compression areas of the soffit and were considered to be the effects of spalling. It was clear that the slab in question required immediate additional support and the rest of the building required core testing.
