FAILURES IN CONCRETE STRUCTURES

Case Studies in Reinforced
and Prestressed Concrete

Robin Whittle

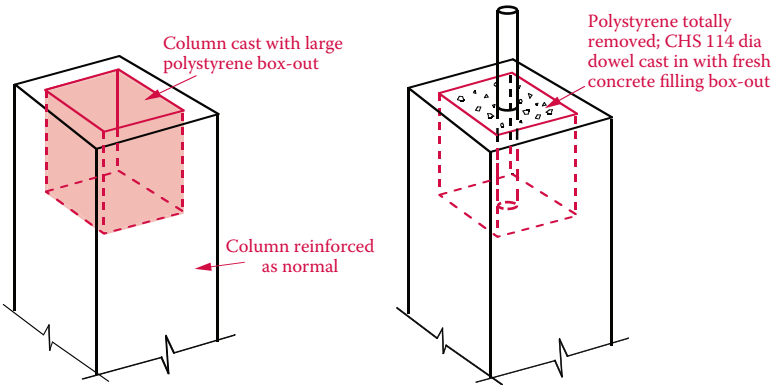
Figure 11.3 Intended construction of top of in situ column.

The construction of the in situ columns should have proceeded as shown in Figure 11.3. The central circular hollow section (CHS) dowel was cast into the top of the in situ column ready to receive the precast column.

The load in the precast column from seven floors above transferred to the outer rim of the in situ column. This load was intended to be taken by the whole section of the in situ columns. However, the thin layer of concrete at the top of the box-out and the polystyrene below were quite incapable of taking any significant load. The outer shell of in situ concrete that had to take the load became overstressed and consequently cracked, providing the first sign of imminent failure (see Figure 11.5).

In order to repair the tops of the in situ columns, the load from the precast building had to be removed. This was achieved by providing props and

jacks close to the existing precast columns at each floor level and creating a new load path to the ground. This released the load on the in situ columns below and allowed the required remedial work—reconstruction of the tops of the in situ columns—to take place.

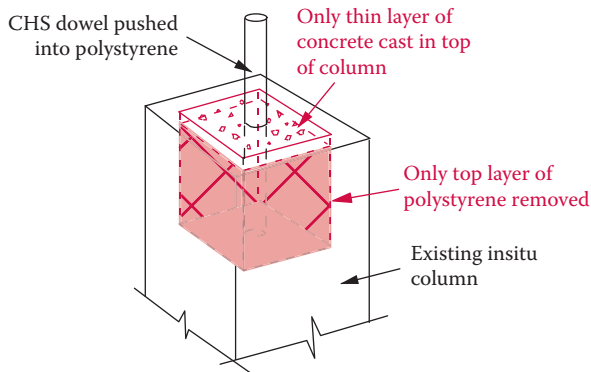
In order to check that the concrete in the box-out was in place as intended, holes were drilled through each face. It was discovered that the polystyrene had been left in and only a thin layer of concrete had been placed at the top (see Figure 11.4).

Figure 11.4 Actual construction of top of in situ column.

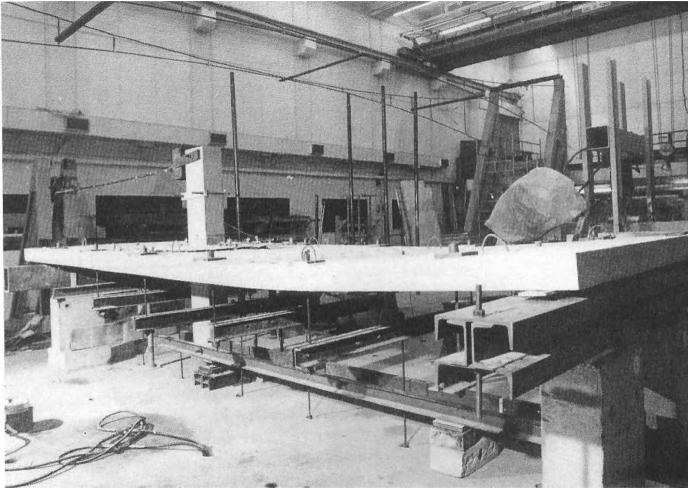
Figure 13.1 Flat slab tests carried out at Polytechnic of Central London. (Courtesy of Jonathan Wood.)

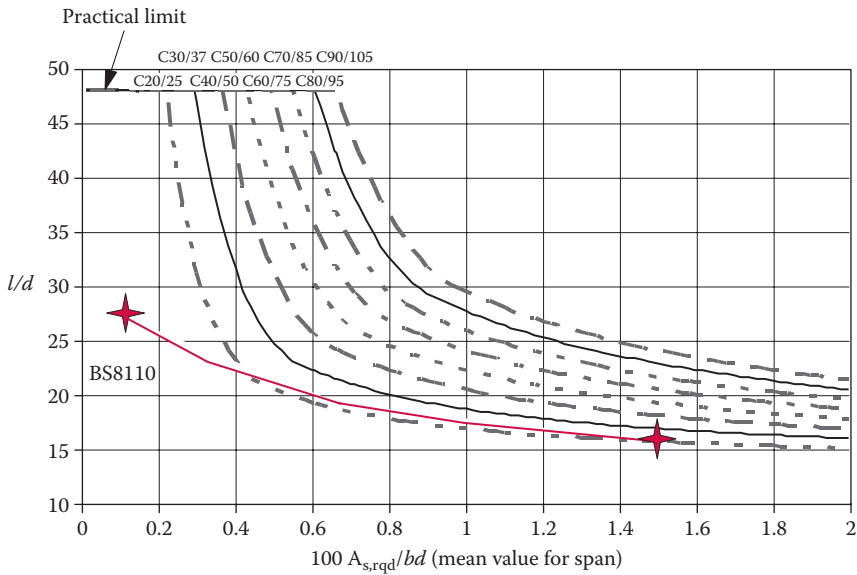
Professor Beeby, who provided the supporting information for the existing code clauses, was asked whether it was appropriate to make an adjustment to the span and/or effective value for the strength of concrete. After further research, he provided an expression to include this variable. Figure 13.2 shows a plot of the expression that was adopted in the technical report and later, in 2004, was also included within *Eurocode 2*.²

Figure 13.2 Effect of concrete strength on span and effective depth ratios.

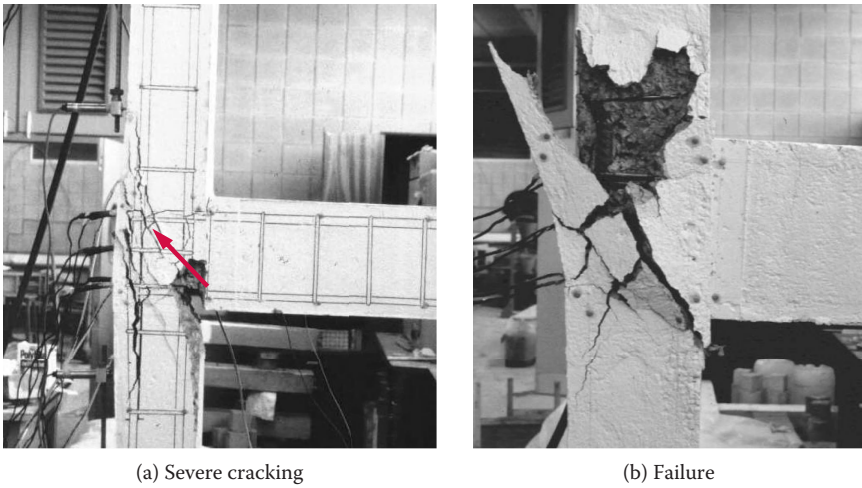
were halved. A slot was cut down the centre of each of bar and the strain gauges placed along one bar at varying pitches (as little as 50 mm) and glued into position. The two halves were then joined to simulate a single complete bar. All the wires from the strain gauges were led out of the ends of the bars to a control box. Figure 13.3 shows one of the tests at the point where the joint failed.

Different arrangements of reinforcement were detailed and tested. One important result showed that if the beam top bars were bent upward in the column, with gravity loading on the beam, the joint resistance was drastically reduced compared with the bars bent down. The reason is that the high compression force created within the joint was not resisted by the enclosing bar as shown in Figure 13.3a.

Figure 13.3 Loading column joint to failure. (Courtesy of Richard Scott.)

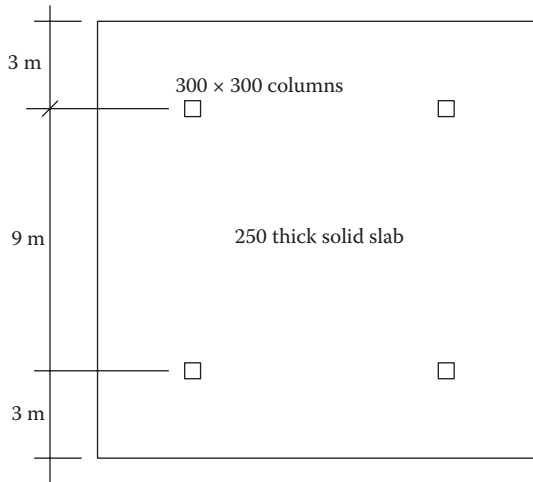
Figure 13.4 Layout of Taywood test flat slab.

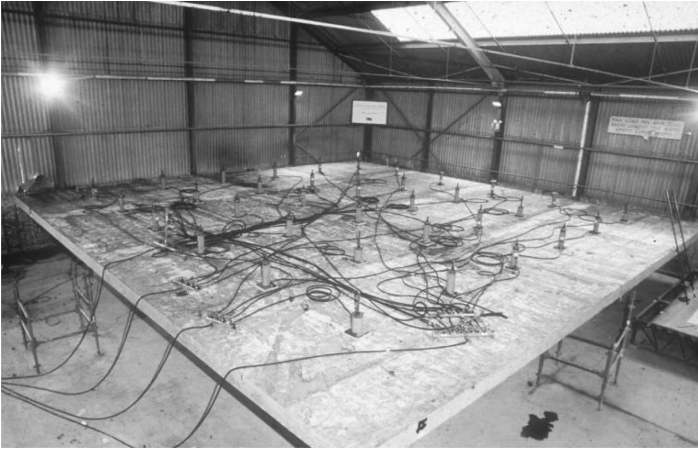
Figure 13.5 Construction of test flat slab. (Courtesy of Richard Scott.)

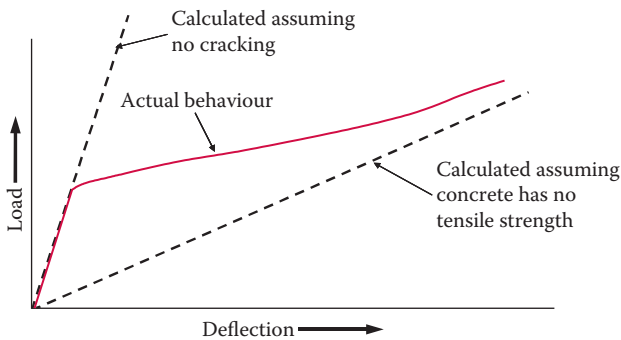
The solution to this problem came about as a result of a chance meeting with Prof. Andrew Beeby two years later. He suggested that he and Dr. Richard Scott carry out tests at Leeds and Durham Universities to examine the concrete tension stiffening effects in more detail. The project was an unmitigated success and resolved the problem with respect to the Taywood Engineering slab. It revealed that what had been considered short term effects of tension stiffening lasted much less time than assumed and that the long term effects took over after a few days. Figure 13.6 shows how tension stiffening affects the behaviour of a concrete element.

Figure 13.6 Effect of concrete tension stiffening on deflection of slabs.
